THE GRAND BAHAMA PORT AUTHORITY, LIMITED

2nd March 2015

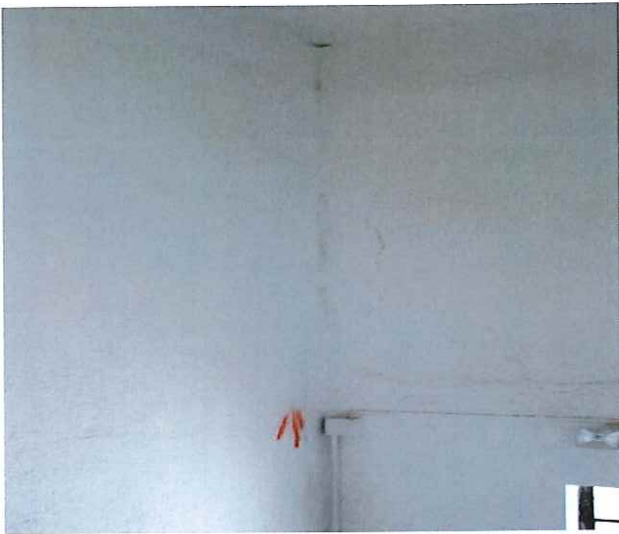
Photo #1 - illustrating moderate concrete crack defects within the eastern stairwell.

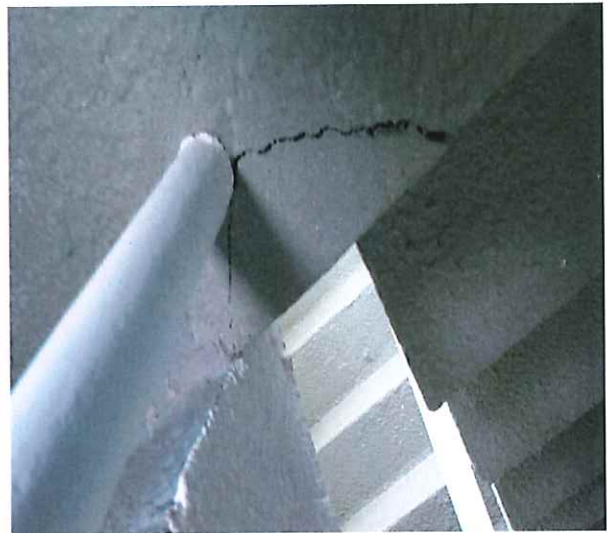
Photo #2 - illustrating moderate to severe concrete crack defects within the western stairwell.

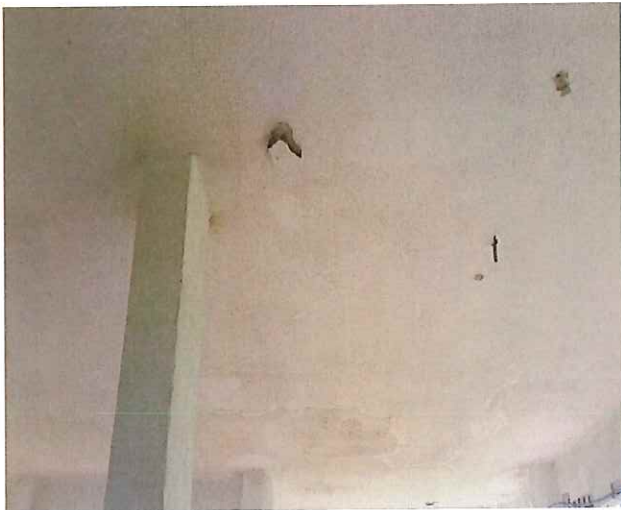
Photo #3 - illustrating severe, concrete crack defects within the ceiling at south-west ground floor ceiling areas exposed to the elements at the open "Breeze-way" areas.

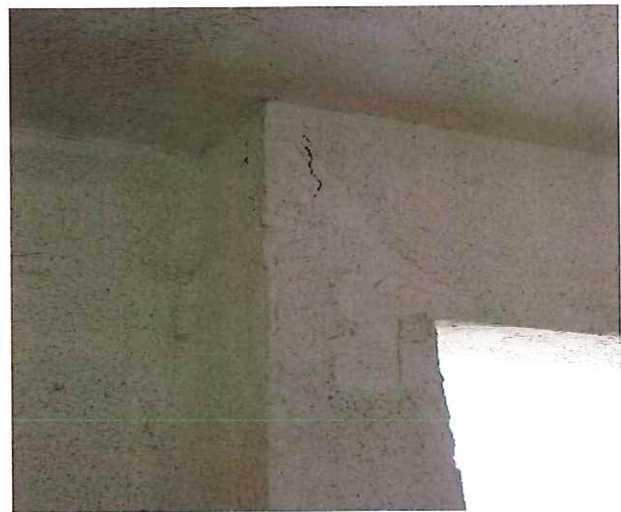
Photo #4 - illustrating moderate, concrete crack defects at the eighth (8th) floor near room #82.

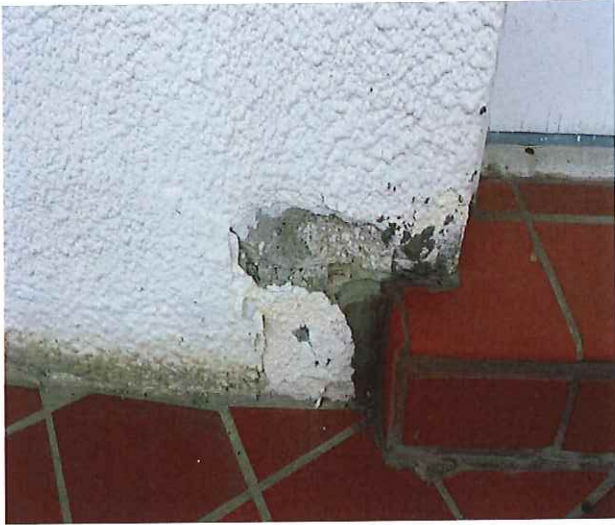
Photo #5 illustrating a moderate concrete crack defect at the base of the CMU wall within the walkway area.

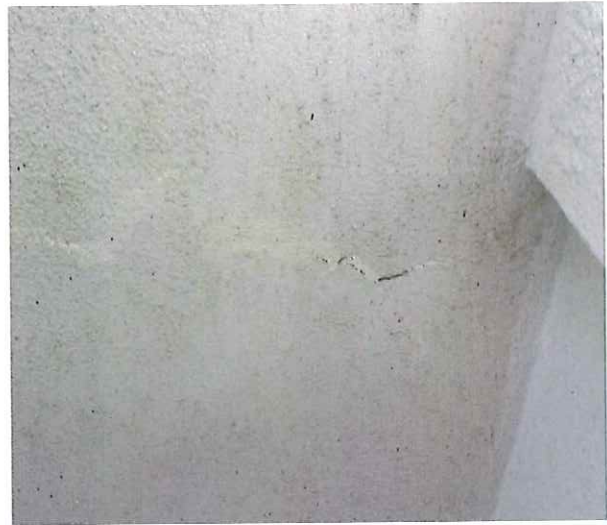
Photo #6 illustrating moderate concrete crack defects within the ceiling of the walkway.

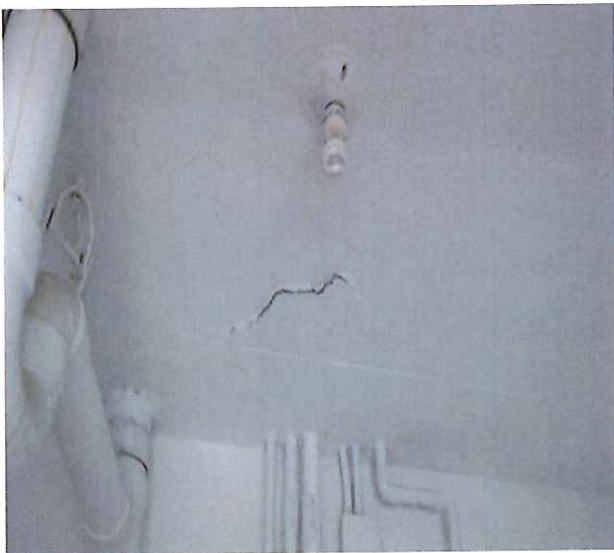
Photo #7 illustrating severe concrete crack defects within the Laundry room at the Sixth floor.

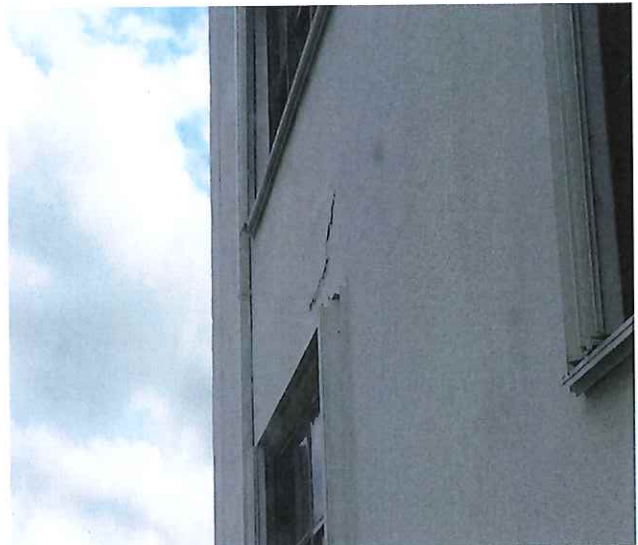
Photo #8 illustrating severe concrete crack at the exterior CMU wall at the south-east section.

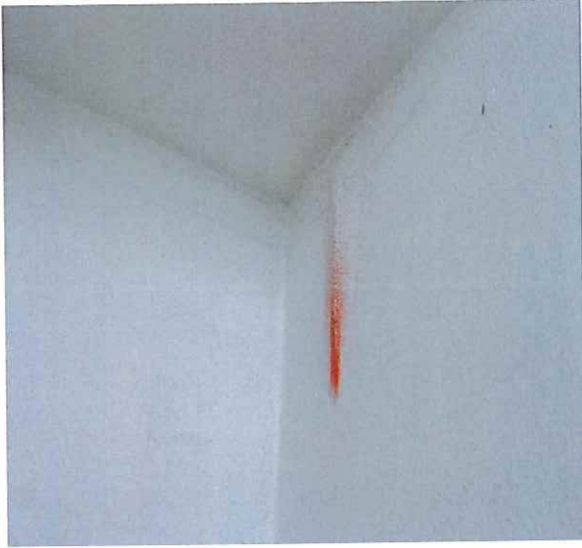
Photo #9 illustrating moderate concrete crack defects at the eastern stairwell CMU walls.

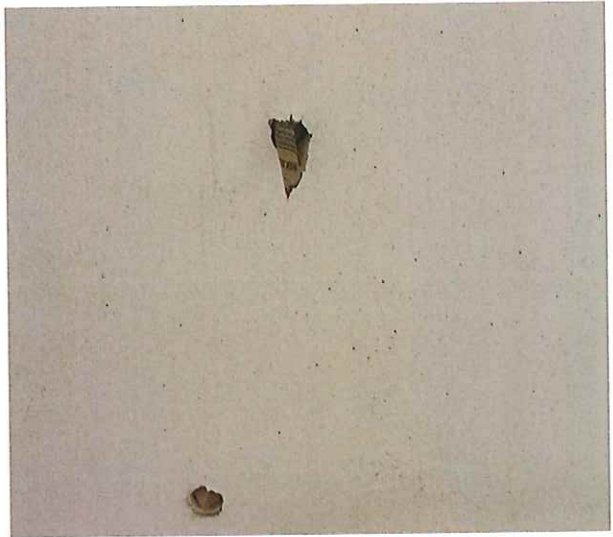
Photo #10 illustrating moderate concrete crack defects at the ceiling of the south western ground floor breeze-way area.

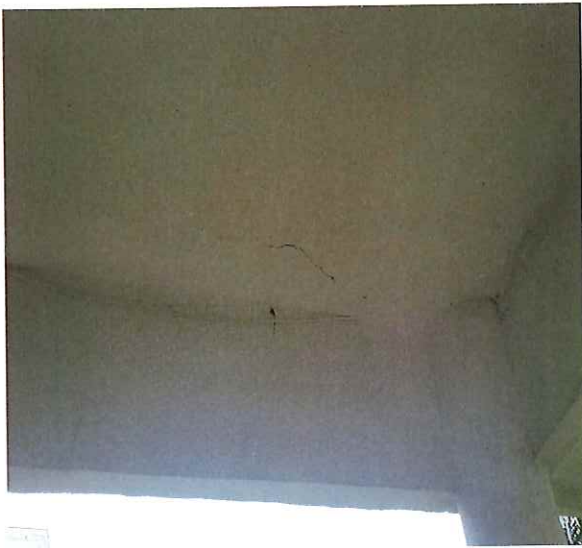
Photo #11 illustrating moderate, concrete crack defects at the concrete ceiling of the southern breezeway area.

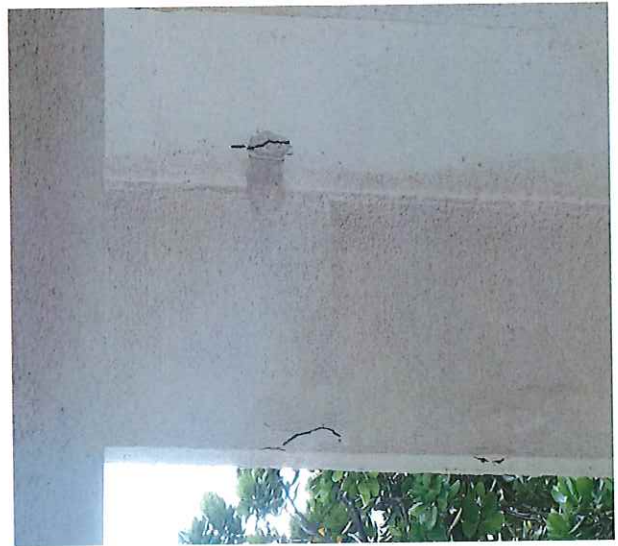
Photo #12 illustrating moderate concrete crack defects at the reinforced concrete beam supporting the second (2nd) Floor concrete floor slab at the south western ground floor breezeway area.

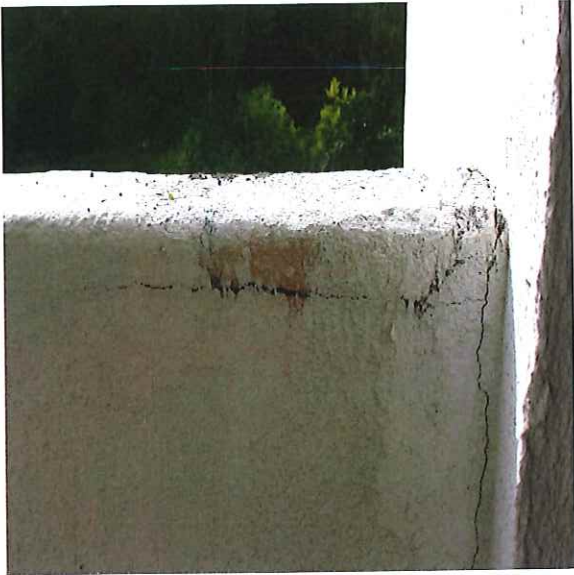
Photo#13 illustrating moderate, concrete crack defects at the CMU balcony rail.

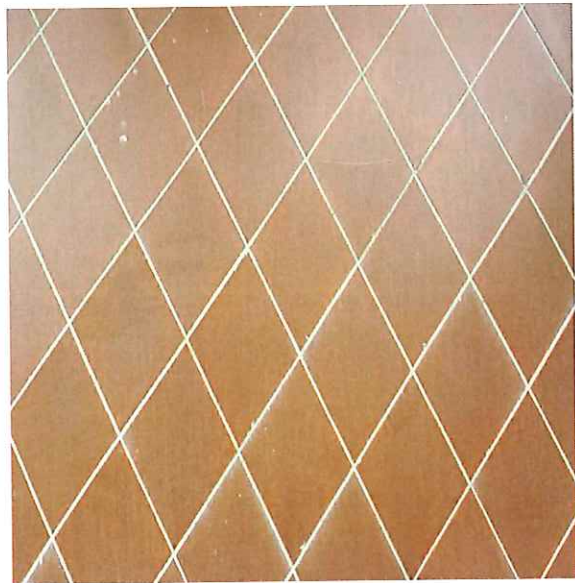
Photo #14 illustrating newly laid tiles as an indication that work was done recently to this area on the 3rd floor balcony located between the central elevator and the western stairwell.

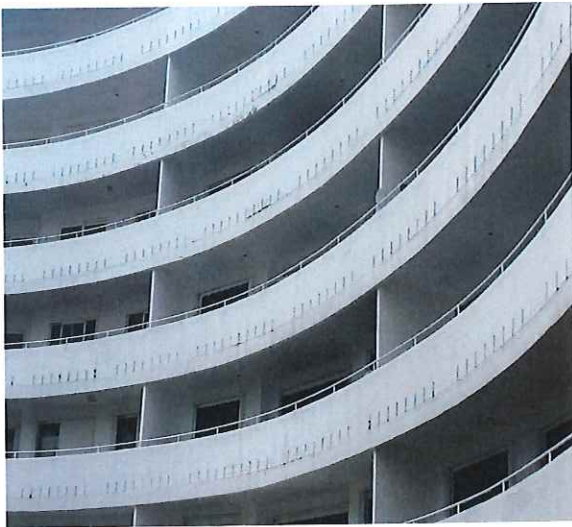
Photo#15 illustrating severe concrete crack defects at the southern CMU balcony rails.

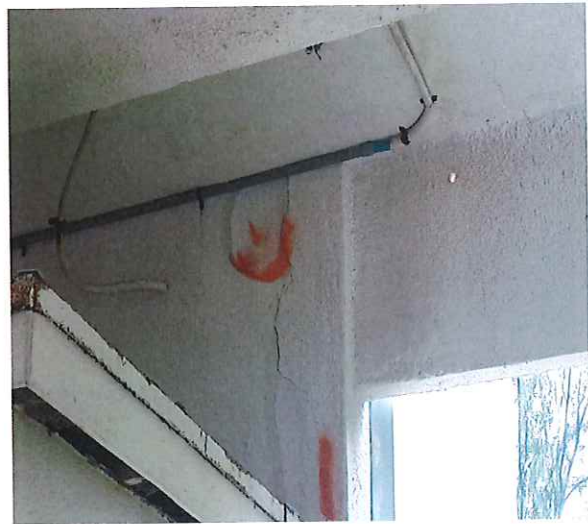
Photo #16 illustrating severe concrete crack defects at the reinforced concrete columns supporting the first level concrete beams at the south western breezeway area.
