Silver Point Condominium

Balcony and Walkway Inspection

Inspection Report and Recommendations

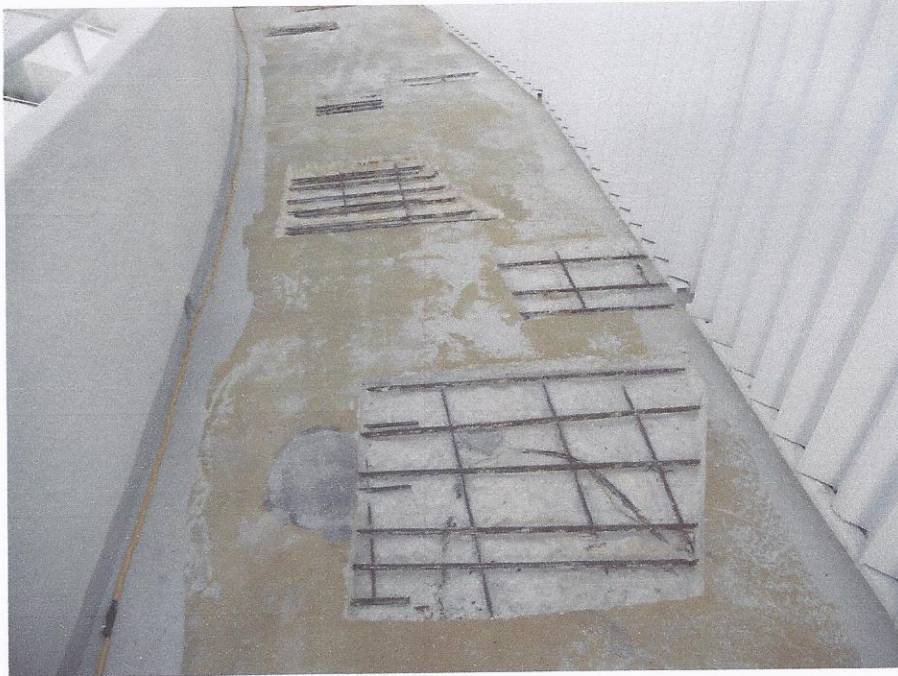
Repairs underway on unit 81 November 2012-typical of expectations

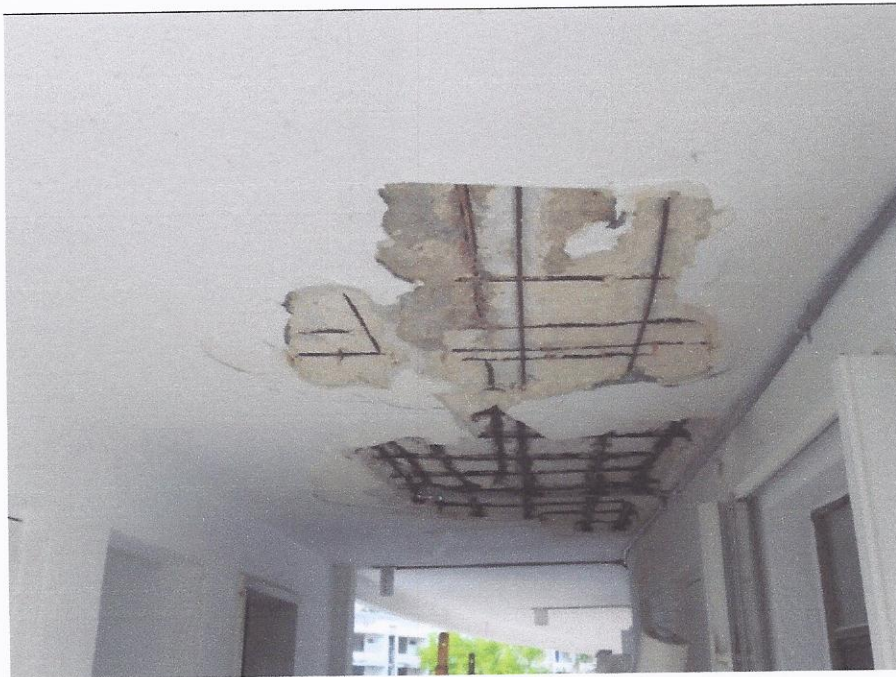
Repairs underway on 2nd level walkways-west end near elevator-November 2012

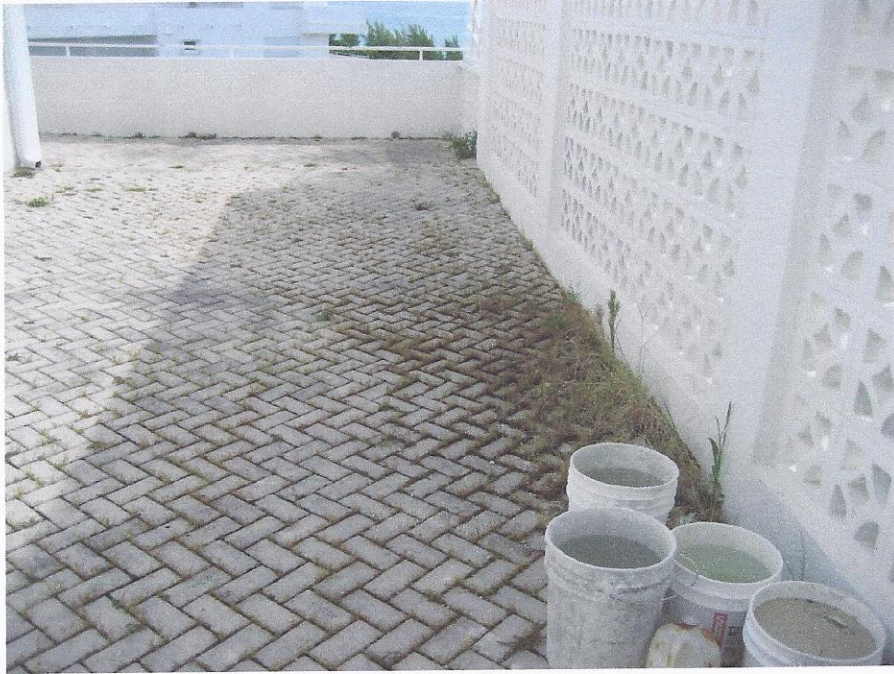
The balcony and walkway surfaces should also be better protected from the elements once repairs are completed using appropriate decorative water resistant coating systems. The existing tile and paver finishes are inappropriate finishes to adequately protect the structural components of the building. The tile will tend to hide concrete damage allowing it to worsen before repairs are initiated.

View of Pavers on Penthouse balconies-poor protection for structure

The best course of action is to remove all of the existing exterior balcony and walkway floor finishes to allow for proper repairs and subsequent application of protective finishes. As part of the structural repairs, integrate Impressed Current Cathodic Protection to provide the best technology available to prevent future concrete damage due to reinforcing steel corrosion. Finally, utilize proper coatings and sealants to protect and beautify the building.

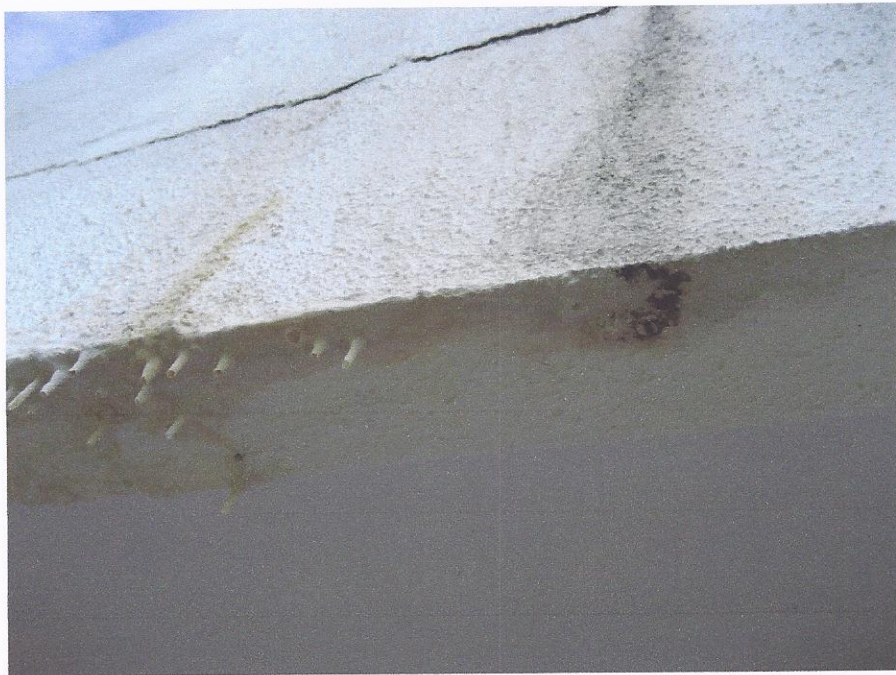
View of leaking evidence at Walkway knee wall edges

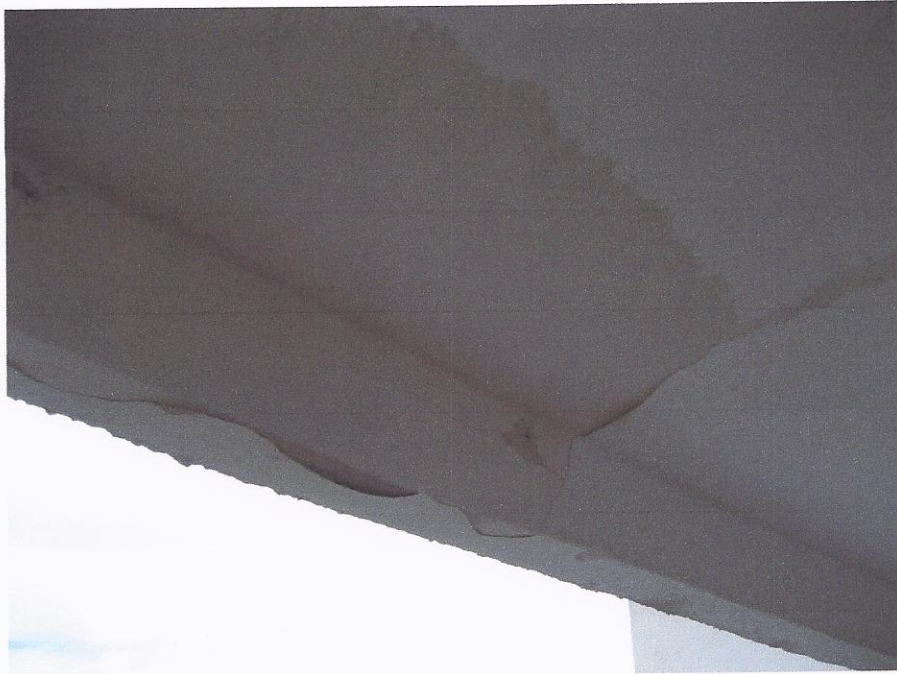
There also appears to be an inappropriate application of elastomeric paint on the balcony and walkway ceiling surfaces. Elastomeric coatings are appropriate for vertical surfaces and top surface applications to keep moisture out. Ceiling surfaces should be finished with a breathable acrylic finish. The combination of porous tile and paver finishes topside with heavy elastomeric underside is an undesirable situation for protection of the structure. Salt laden moisture is allowed easy access to the reinforcing steel via the tile and pavers, while the elastomeric locks it in to prevent drying. This accelerates the corrosion rate unnecessarily in what is already an inhospitable environment. There is much evidence of this trapped moisture intrusion as indicated by the numerous large paint bubbles on the ceilings of the balconies and walkways.

View of improper heavy elastomeric paint applied to walkway ceiling

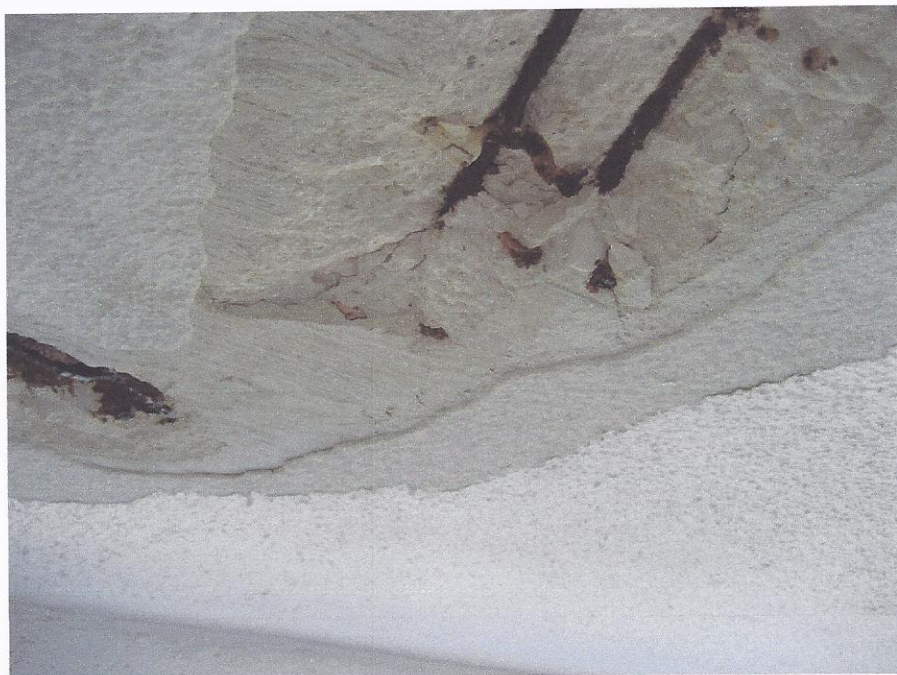
View of exposed concrete spall and rebar corrosion on walkway ceiling

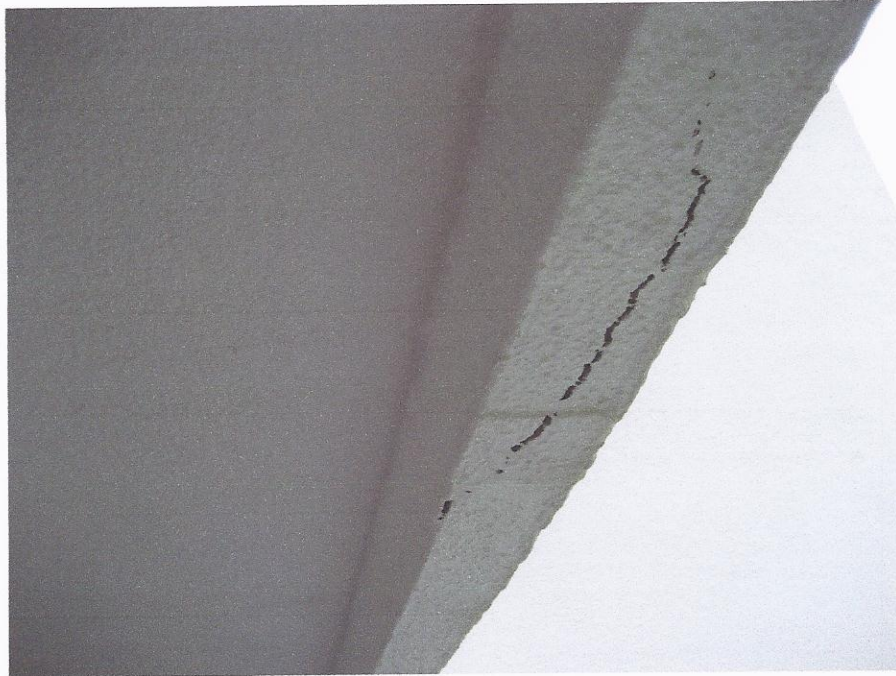
View of typical concrete spall in turned-down perimeter beam

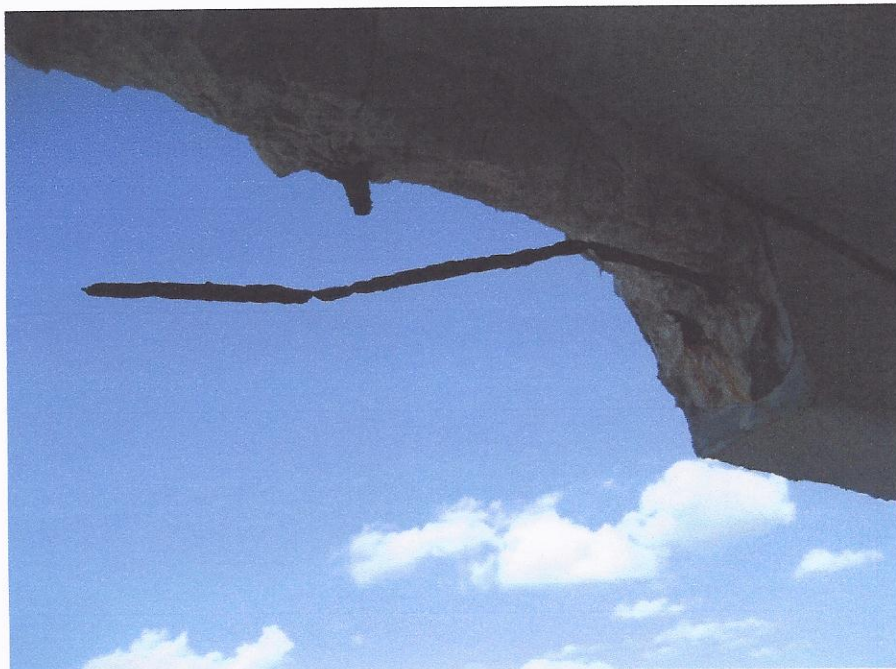
View of exposed reinforcing steel corrosion in turned-down perimeter beam
Note-loss of cross sectional area of steel reinforcement due to corrosion activity

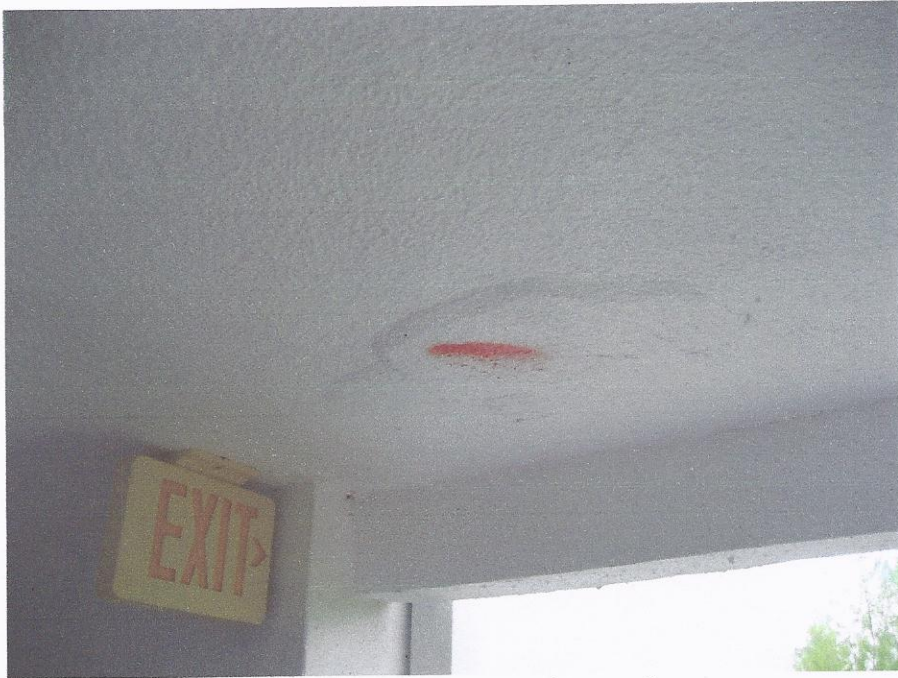
View of unexcavated ceiling spall

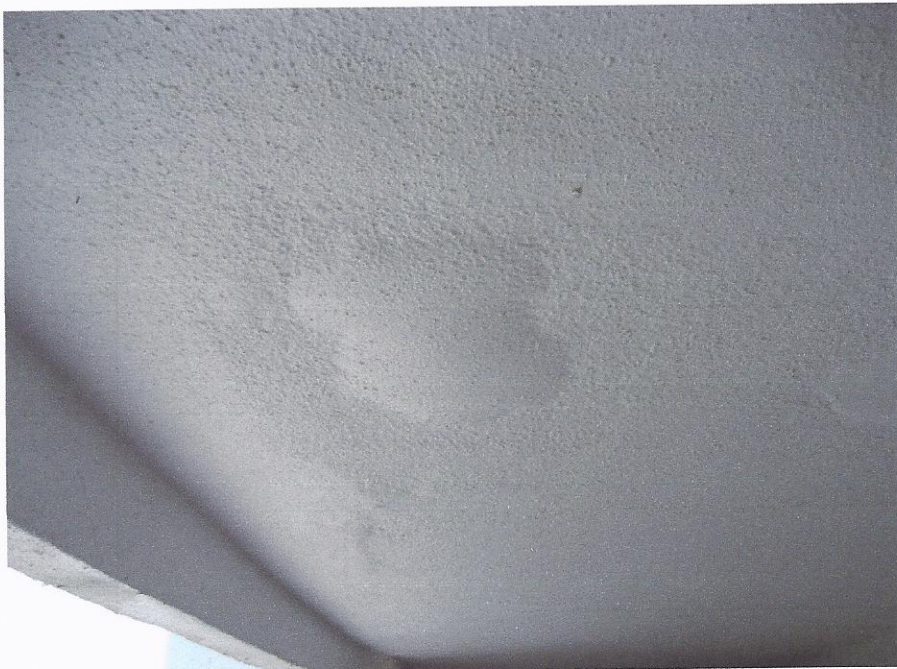
View of paint bubble in ceiling due to water intrusion trapped by elastomeric coating

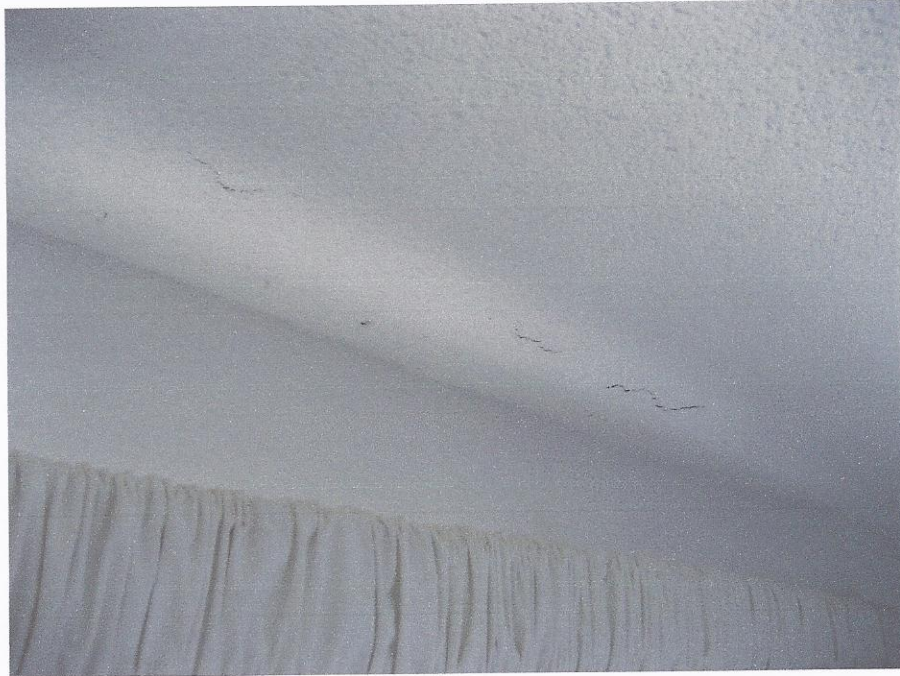
The concrete spalling is occurring at the balcony slab edges, columns, surfaces and ceilings. Some of this damage is encroaching and/or occurring under the sliding glass door tracks. This can and will affect the operation of the sliding glass doors as the tracks are pushed up and bent. There was also evidence of concrete damage inside of the units beyond the sliding glass door tracks.

View of interior concrete spalling at ceiling near balcony sliding glass door

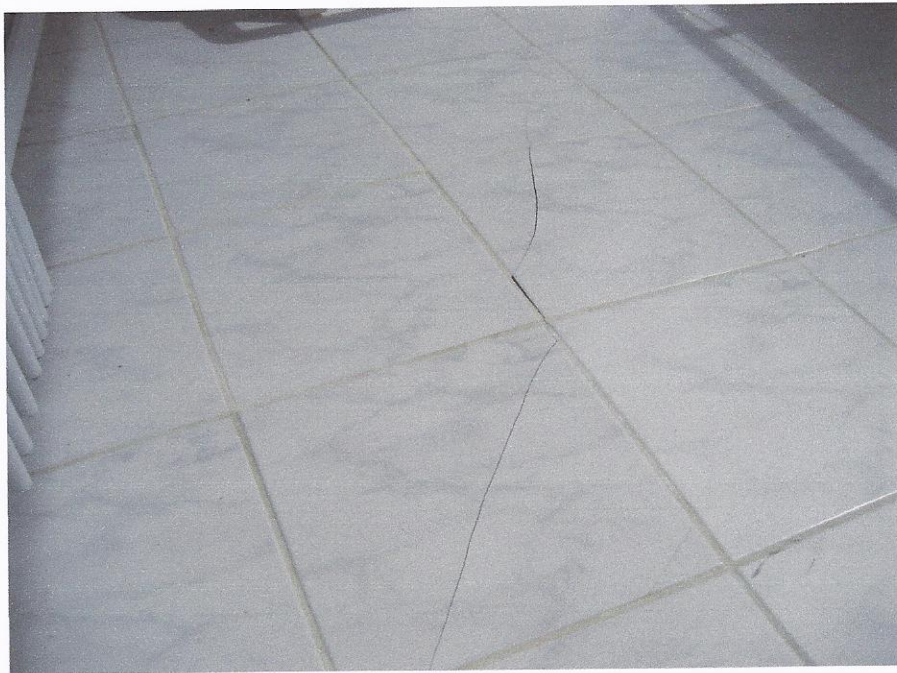
Example of probable concrete spalling under cracked tile on balcony

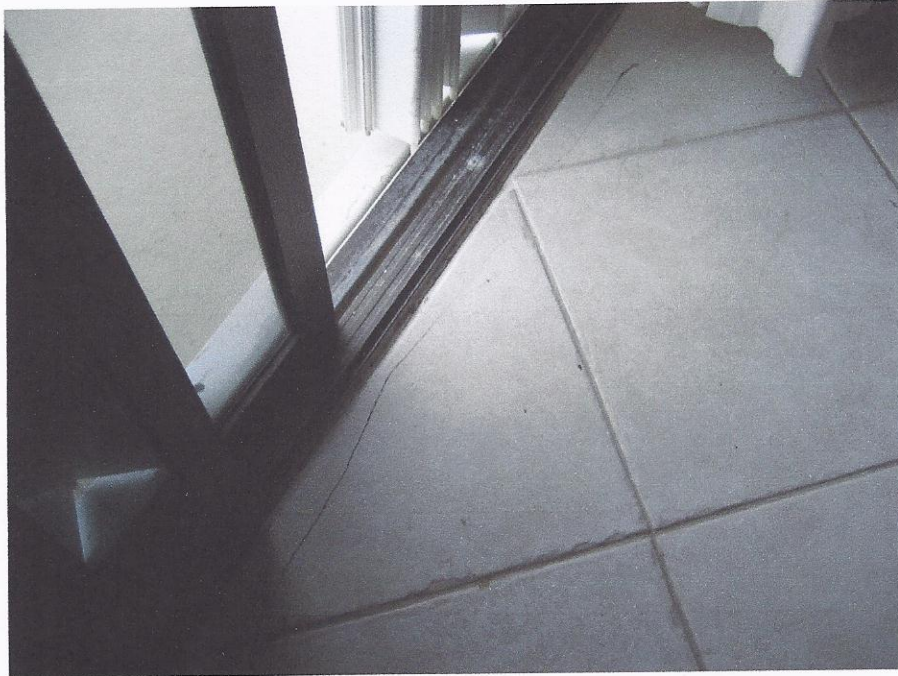
Example of probable interior spalling under cracked tile

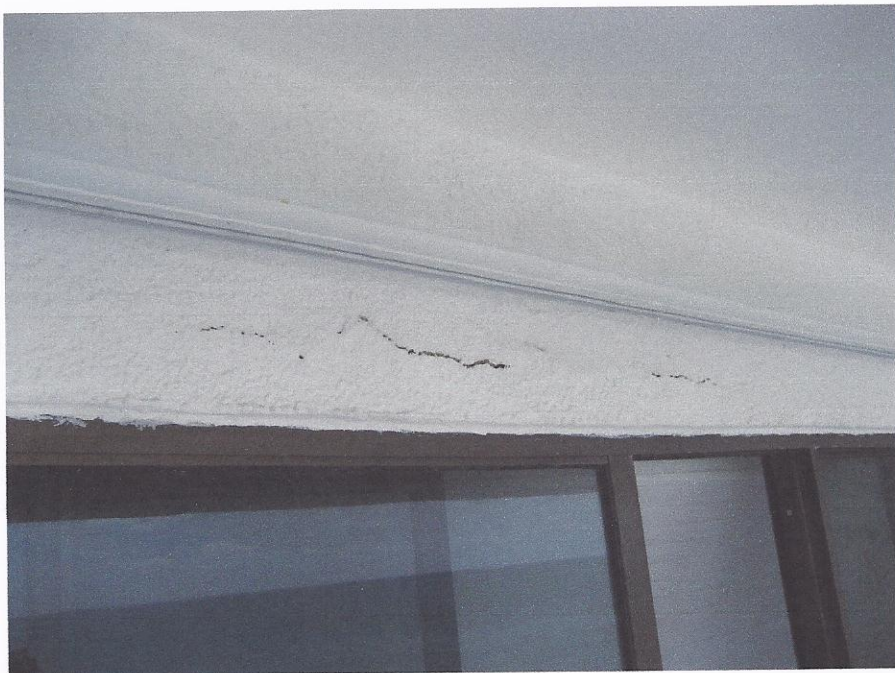
Example of spalled header beam above sliding door

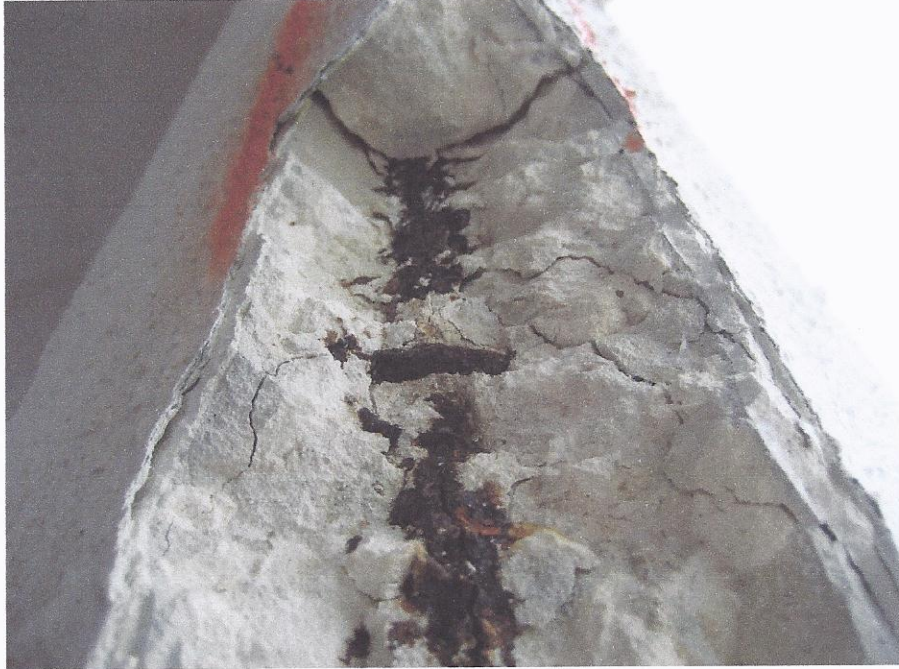
Example of spalled concrete at vertical support column

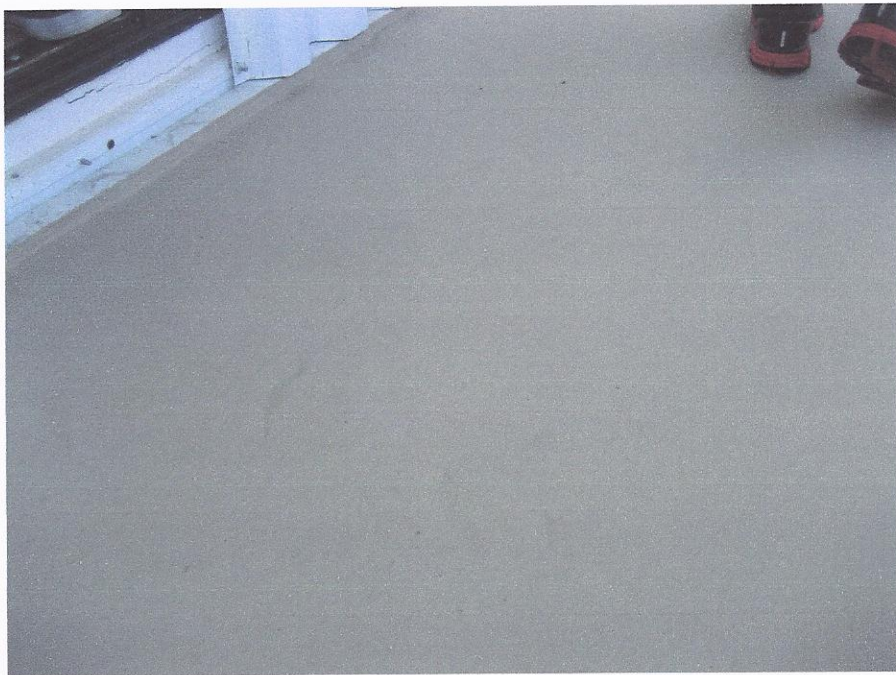
Example of unexcavated floor spalls
