“Full” Reserve Study

Sample Condo Anywhere, US

Report #: 99991-0

Date Prepared: September 30, 2014

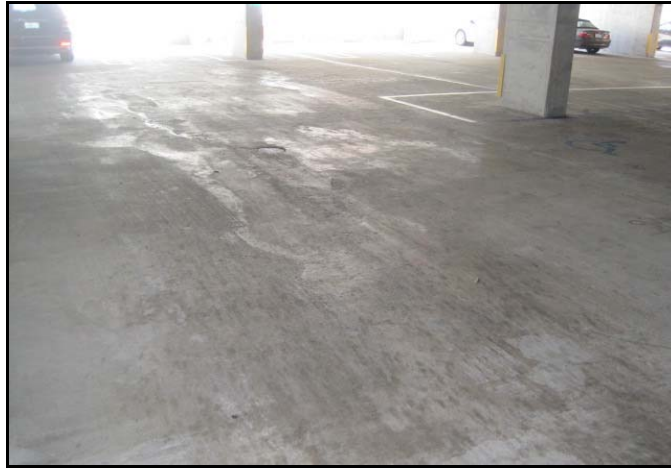
Evaluation: Garage concrete should not be life-limited under normal circumstances. Typical maintenance includes pressure washing, minor crack repairs, and other small projects as needed. Any trip hazards should be fixed right away to avoid liability issues. Ensure that any drains are cleaned regularly to prevent water ponding, and repair or replace sections as needed using Operating funds.

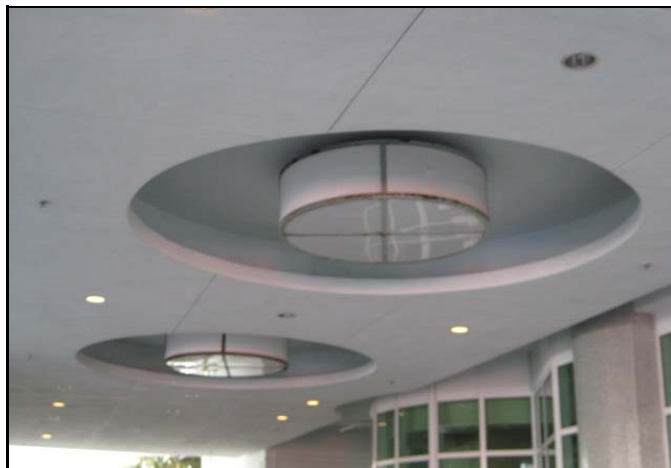
Evaluation: Large, decorative fixtures. Frames were noted to be badly rusted during inspection. Observed during daylight hours, but assumed to be in functional operating condition. As routine maintenance, clean by wiping down with an appropriate cleaner, change bulbs and repair as needed. Be sure to inspect for tight seal with building envelope.

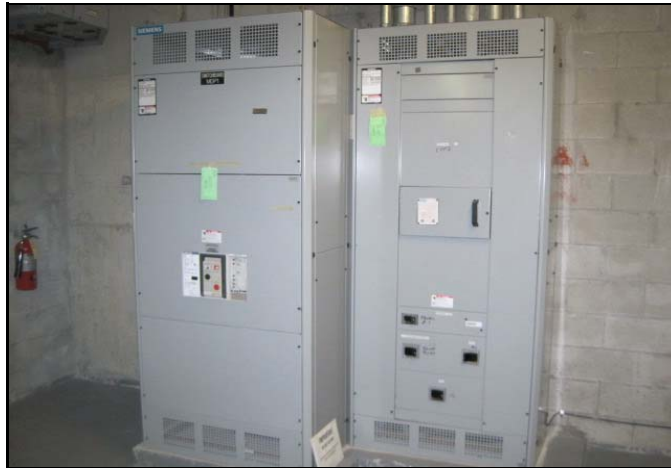
Evaluation: Detailed analysis of electrical system(s) is not within the scope of this Reserve Study. Some electrical system components used historically are known to be life limited, but predictability of failures is very difficult to determine. Manufacturing defects may become apparent from time to time and certain site conditions can contribute to premature deterioration of system components. Typically, if installed per architectural specifications and local building codes, there is no predictable time frame for large scale repair/replacement expenses within the scope of our report. In our experience working with similar associations, service life typically lasts well beyond rated life of components. Treat minor repairs as ongoing maintenance expense. Periodic inspections of distribution system by qualified electrician are wise to clean and tighten, exercise breakers, etc. Some associations employ infrared or other testing methodologies to identify trouble spots and potential hazards. Funding may be incorporated into future Reserve Study updates if conditions dictate. Keep track of any relevant expenses and include information during future Reserve Study updates as necessary. No basis for Reserve funding at this time.

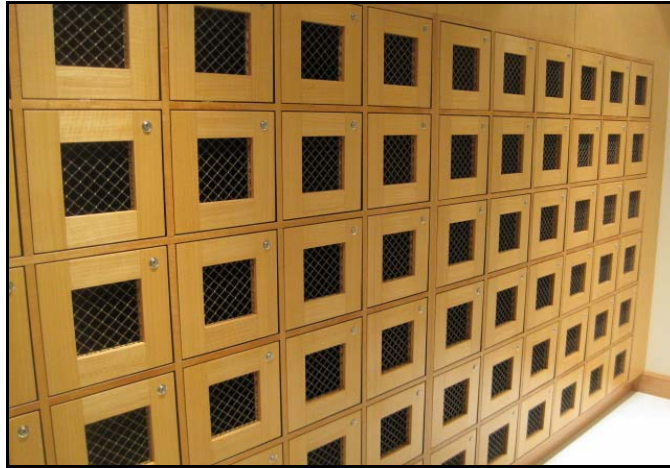
Evaluation: Approximately 325 GSF tile flooring. (1) table and area rug at adjacent hallway. A total of (144) lockers in place. Manager reports that these rooms have never been used. No wear or damage noted. Schedule and cost estimates should be re-evaluated during future Reserve Study updates and adjusted as needed based on the association's good judgment.

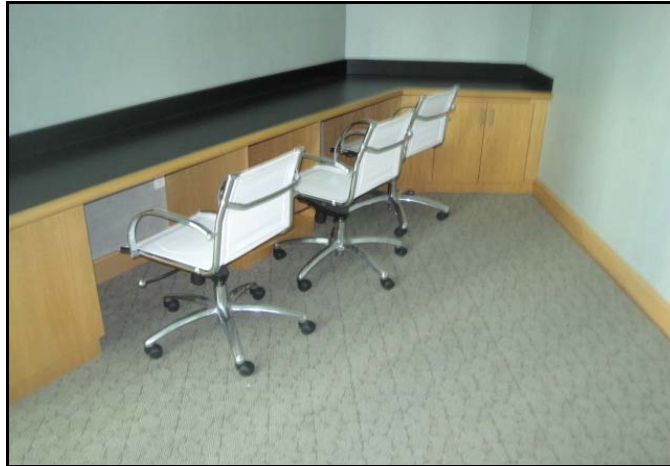
Evaluation: (1) fax/printer, (3) desk chairs, (1) ceiling light and approximately 14 GSY of carpeting. Restricted access to this room. Only light use/wear noted. Life estimates can vary greatly depending on level of use and preferences of association. Schedule and cost estimates should be re-evaluated during future Reserve Study updates and adjusted as needed based on the association's good judgment.

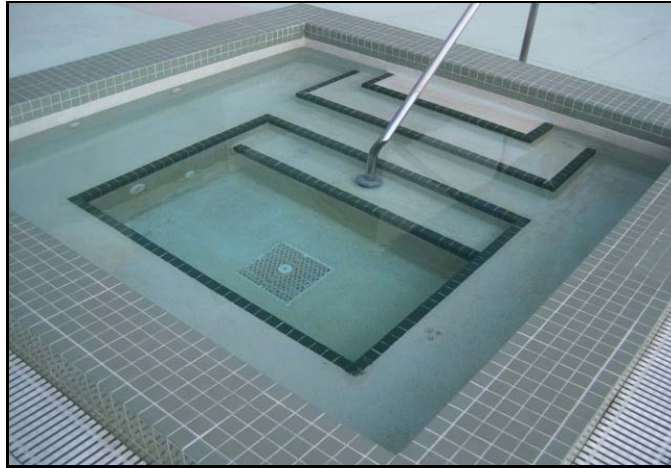
Evaluation: Generally good condition noted during inspection. Spas sometimes need to be resurfaced more frequently than pools due to higher temperatures, but both should be done at the same time whenever possible to achieve better pricing and minimize downtime. Resurfacing will restore the aesthetic quality of the spa while protecting the actual concrete shell from deterioration. While drained for resurfacing, any other repairs to lighting, handrails, stairs, ladders, etc. should be conducted as needed. This type of project is best suited for slow/offseason to minimize downtime during periods when spa is used heavily. Should be expected at the approximate interval shown below to preserve this important amenity of the association.

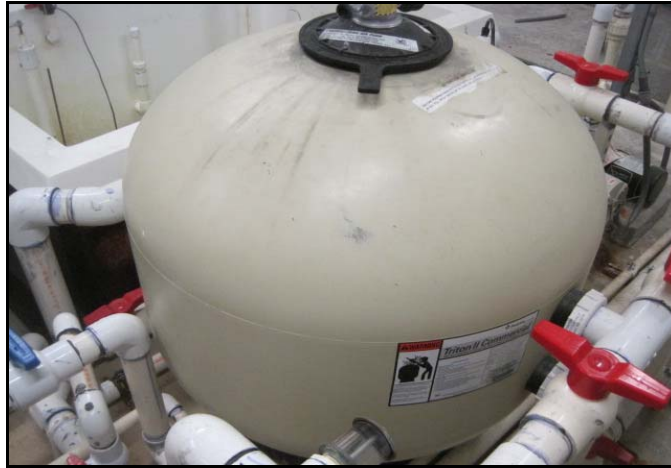
Evaluation: Pentair Triton II sand filter, model TR140C, appears to be original. Pool vendor should inspect regularly for optimal performance and address any repairs or preventive maintenance as needed. Life can vary depending on location, as well as level of use and preventive maintenance. In most cases, replacement cost does not meet threshold for Reserve funding. Replace as needed within annual Operating budget.

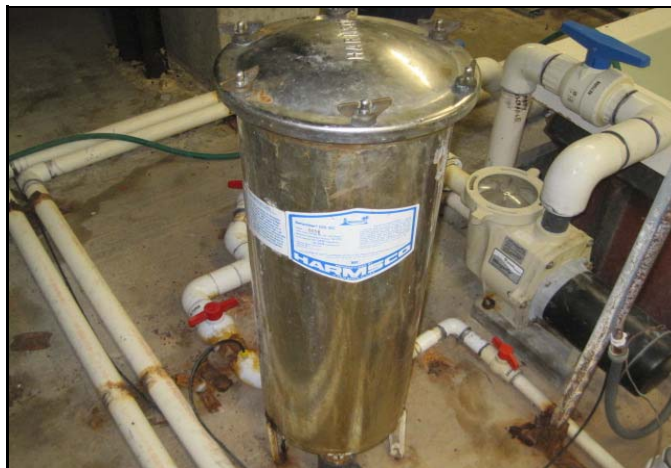
Evaluation: Harsmco "BetterFilter" model 155 SC. Pool vendor should inspect regularly for optimal performance and address any repairs or preventive maintenance as needed. Life can vary depending on location, as well as level of use and preventive maintenance. In most cases, replacement cost does not meet threshold for Reserve funding. Replace as needed within annual Operating budget.

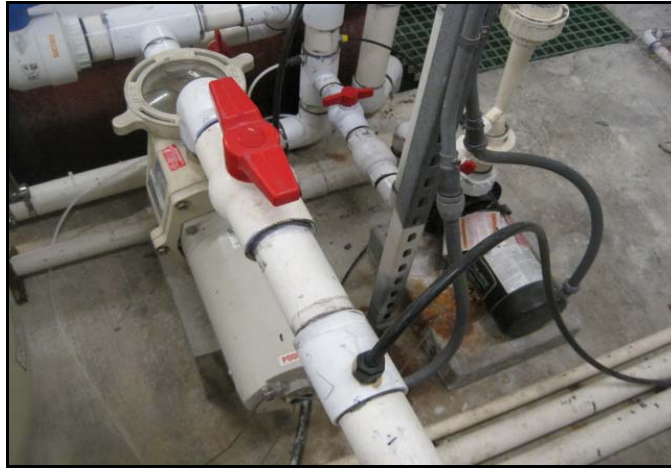
Evaluation: (1) 2 HP and (1) 0.5 HP for pool. (1) 1.5 HP and (1) 3 HP for spa. Pool and spa pumps can be repaired or replaced for relatively low cost in most cases. However, if multiple repairs or replacements are required at the same time, then it may be warranted to use Reserve funds for these expenses. An allowance for ongoing projects is recommended here.

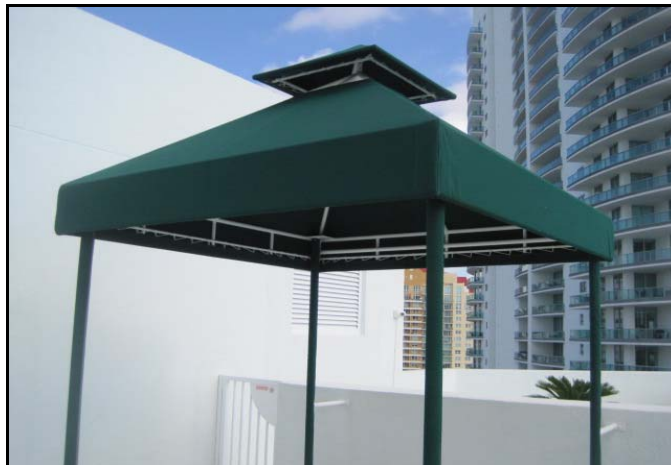
Evaluation: Each awning has an approximate 8'x8' footprint. Fabric appears to be intact with no significant damage. Some rust noted on frame. Overall fair/good condition, but useful life is likely to be fairly short in this location.
