“Full” Reserve Study

Sample Condo Anywhere, US

Report #: 99991-0

Date Prepared: September 30, 2014

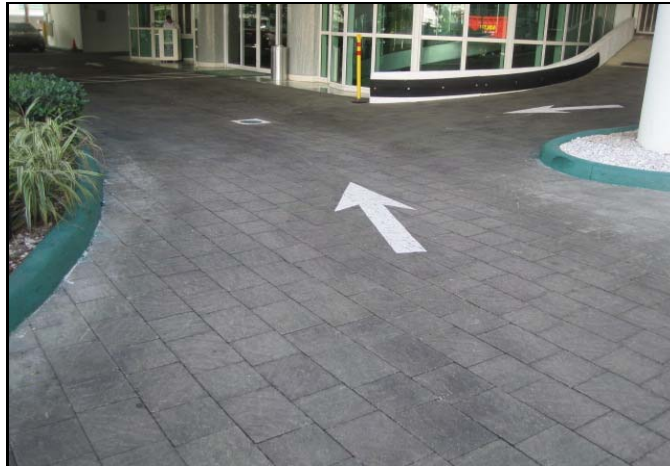
Useful Life:
40 years

Remaining Life:
33 years

Best Case: \$20,900.00
Lower estimate to replace

Worst Case: \$27,800.00
Higher estimate

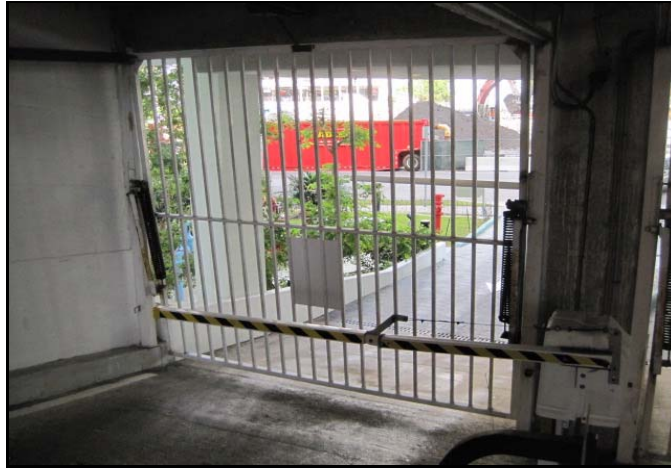
Remaining Life:

13 years

Best Case: \$8,900.00

Lower estimate to replace

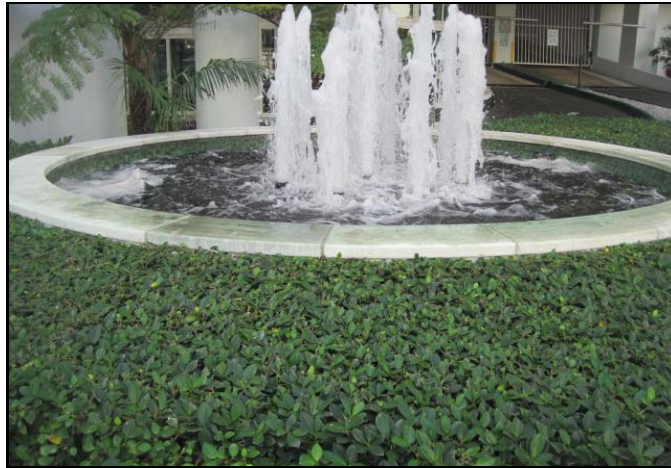
Useful Life:
12 years

Remaining Life:
5 years

Best Case: \$3,600.00
Lower allowance to maintain

Worst Case: \$4,400.00
Higher allowance

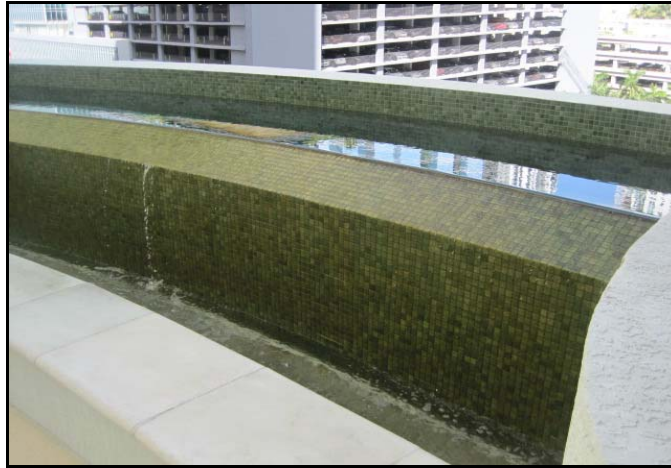
Useful Life:
12 years

Remaining Life:
5 years

Best Case: \$2,500.00
Lower allowance to maintain

Worst Case: \$3,500.00
Higher allowance

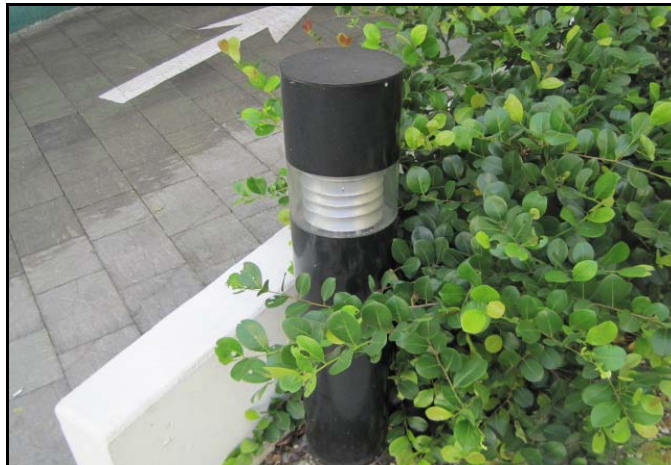
Useful Life:
20 years

Remaining Life:
13 years

Best Case: \$6,500.00
Lower estimate to replace

Worst Case: \$8,500.00
Higher estimate

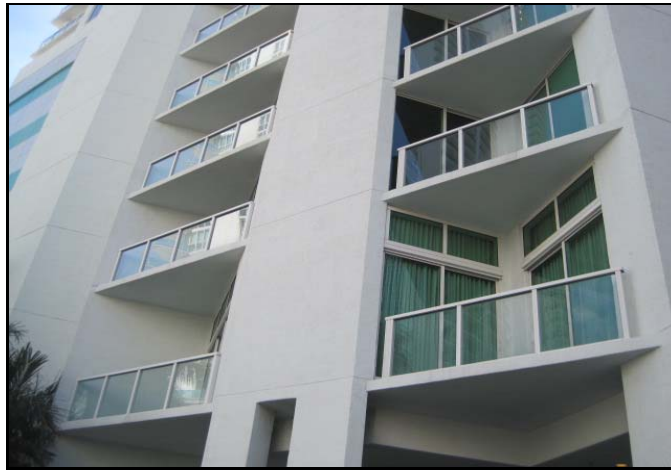
Remaining Life:

16 years

Best Case: \$546,400.00

Lower estimate to replace

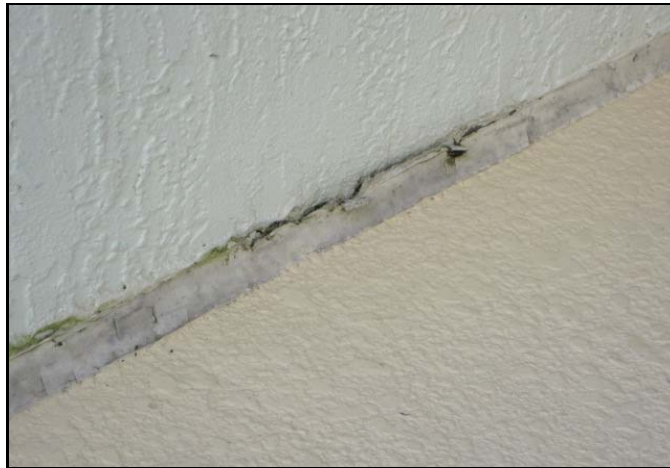
Useful Life:
24 years

Remaining Life:
16 years

Best Case: \$13,700.00
Lower estimate to resurface

Worst Case: \$19,100.00
Higher estimate

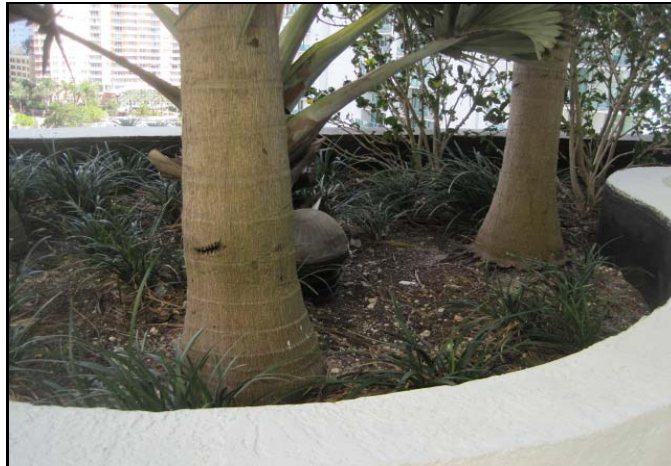
Useful Life:
24 years

Remaining Life:
16 years

Best Case: \$150,500.00

Lower estimate to waterproof/re-plant

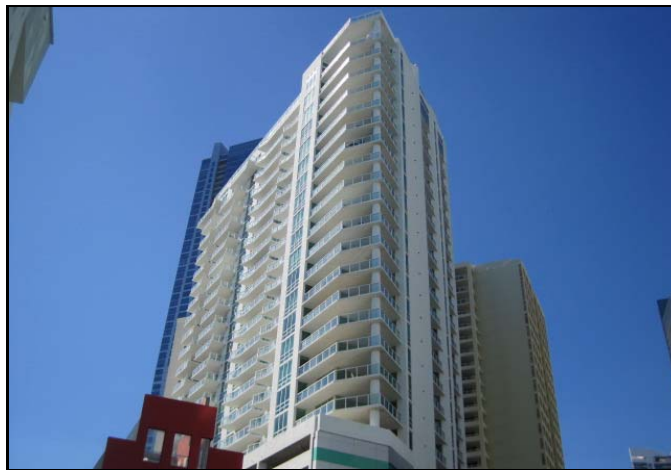
Useful Life:
24 years

Remaining Life:
16 years

Best Case: \$213,000.00

Lower allowance for partial restoration

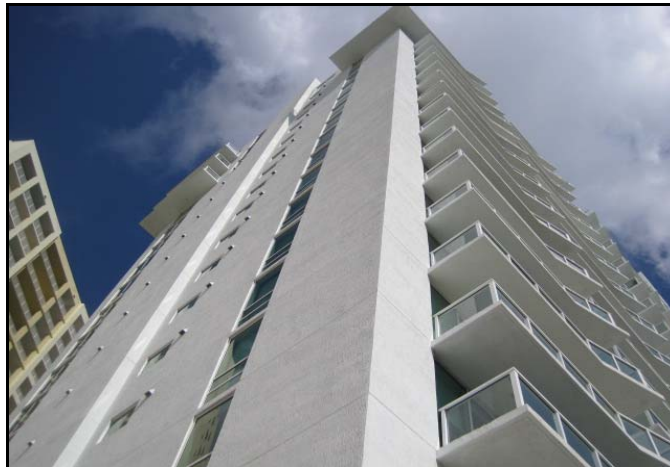
Useful Life:
8 years

Remaining Life:
0 years

Best Case: \$180,000.00
Lower estimate to seal/repaint

Worst Case: \$250,000.00
Higher estimate

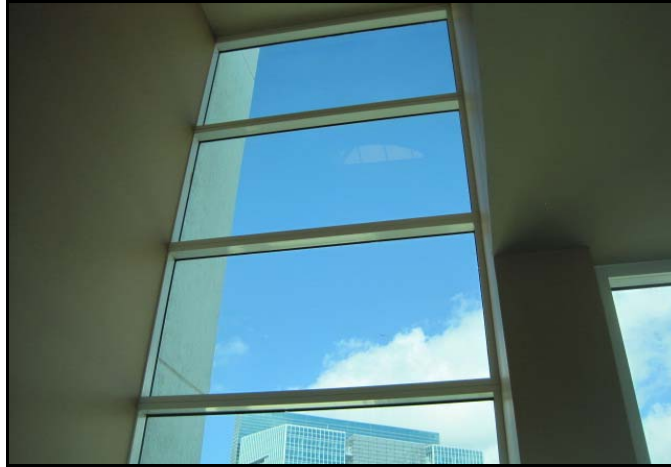
Useful Life:
30 years

Remaining Life:
23 years

Best Case: \$260,500.00
Lower estimate to replace

Worst Case: \$364,700.00
Higher estimate

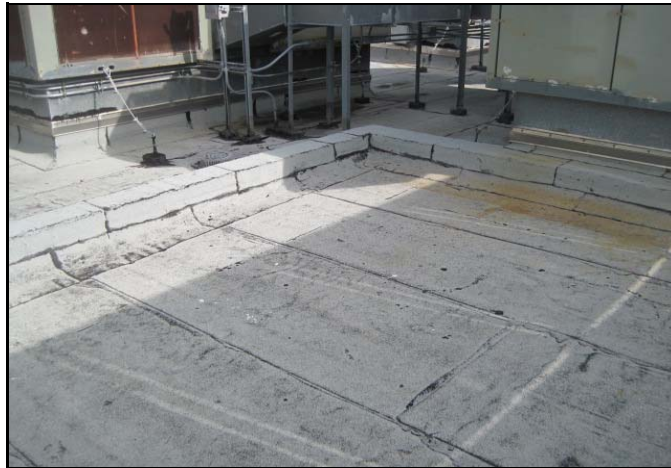
Useful Life:
20 years

Remaining Life:
13 years

Best Case: \$60,000.00
Lower estimate to replace

Worst Case: \$75,000.00
Higher estimate

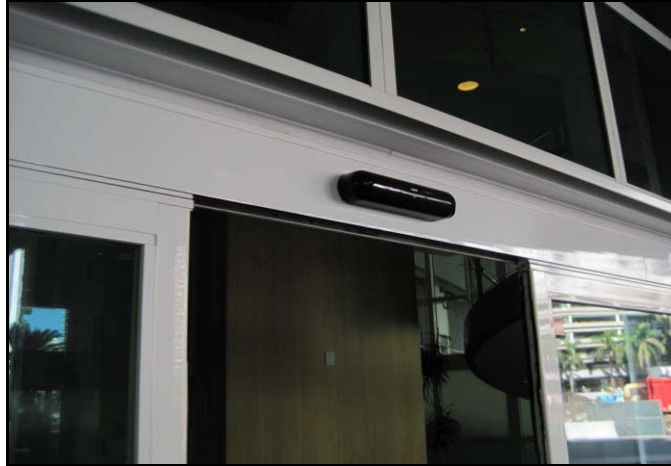
Useful Life:
20 years

Remaining Life:
13 years

Best Case: \$14,000.00
Lower estimate to replace

Worst Case: \$18,000.00
Higher estimate

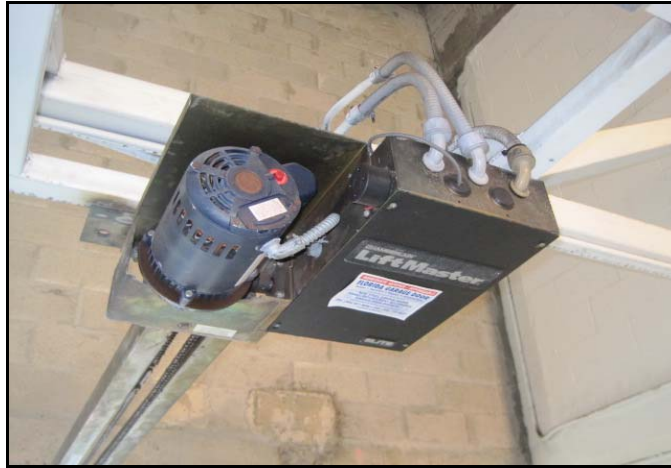
Useful Life:
10 years

Remaining Life:
5 years

Best Case: \$5,000.00
Lower estimate to replace

Worst Case: \$6,000.00
Higher estimate

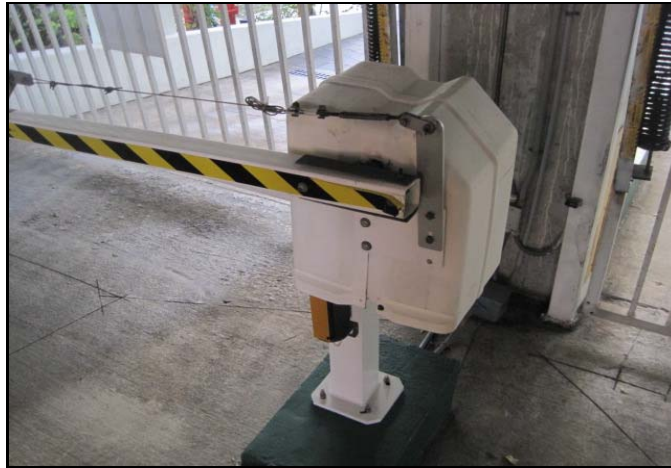
Useful Life:
10 years

Remaining Life:
6 years

Best Case: \$4,500.00
Lower estimate to replace

Worst Case: \$6,500.00
Higher estimate

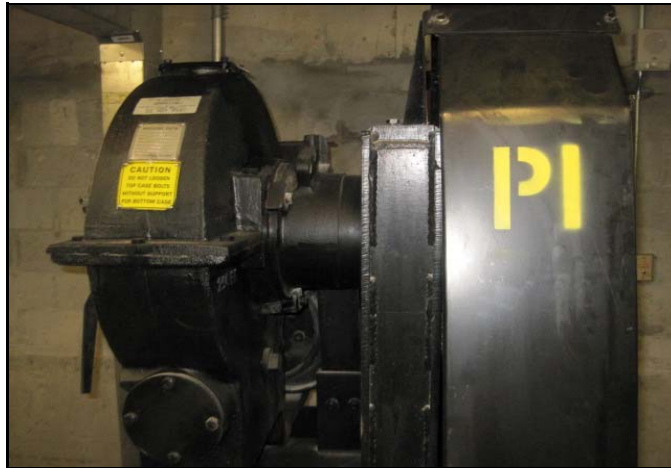
Useful Life:
25 years

Remaining Life:
18 years

Best Case: \$450,000.00

Lower estimate to modernize

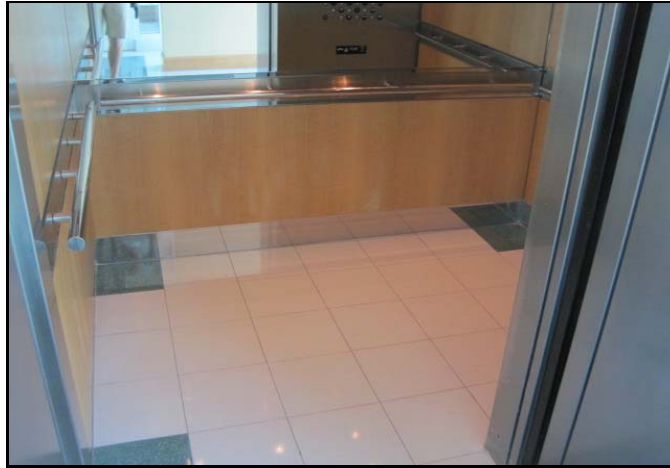
Remaining Life:

18 years

Best Case: \$30,000.00

Lower estimate to remodel

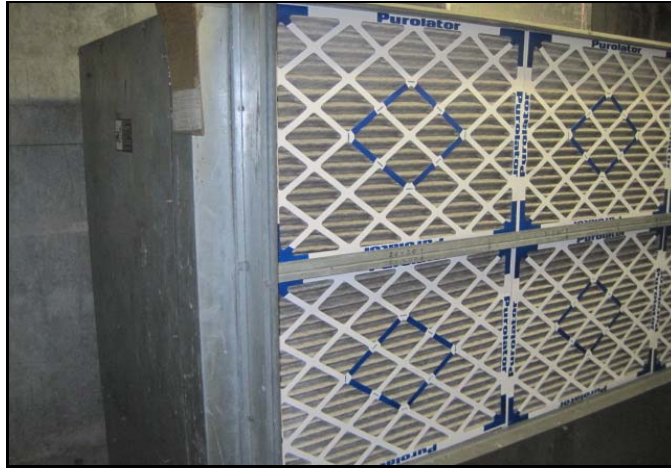
Remaining Life:

8 years

Best Case: \$15,000.00
Lower estimate to replace

Worst Case: \$21,000.00
Higher estimate

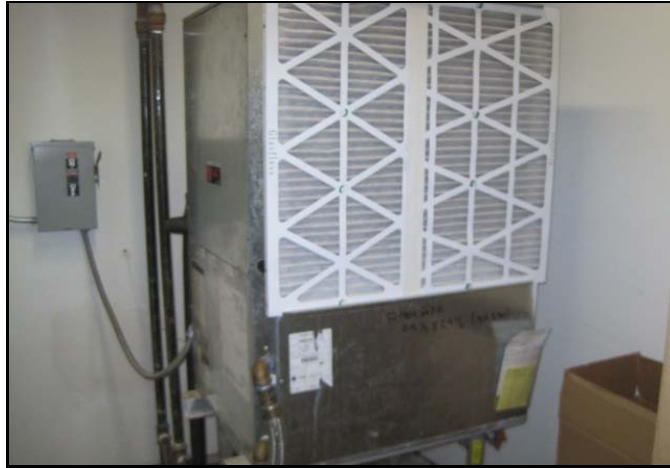
Remaining Life:

8 years

Best Case: \$5,000.00
Lower estimate to replace

Worst Case: \$7,000.00
Higher estimate

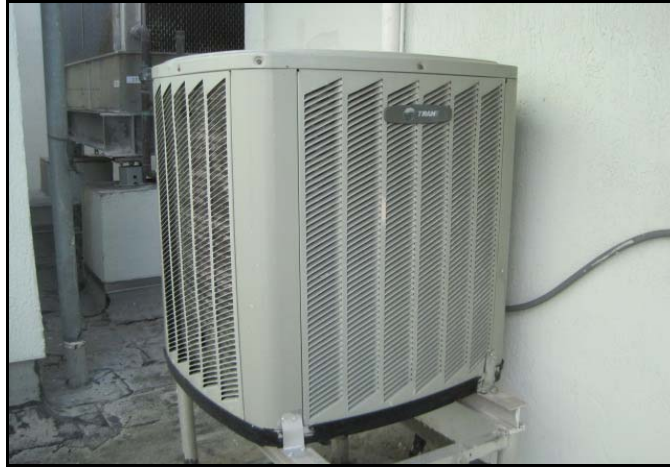
Useful Life:
15 years

Remaining Life:
8 years

Best Case: \$6,500.00
Lower estimate to replace

Worst Case: \$8,500.00
Higher estimate

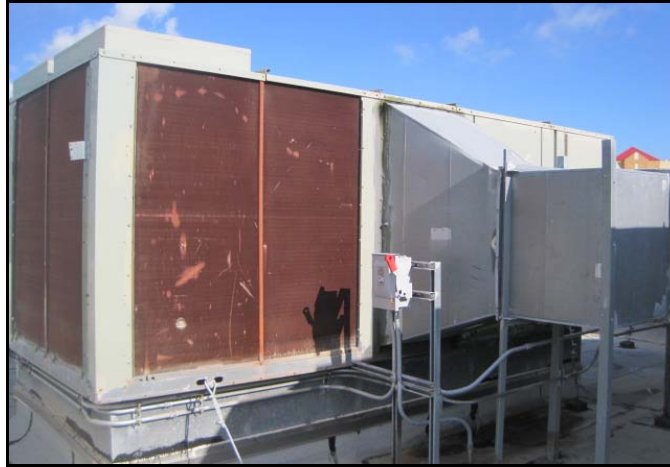
Useful Life:
15 years

Remaining Life:
8 years

Best Case: \$86,400.00
Lower estimate to replace

Worst Case: \$105,600.00
Higher estimate

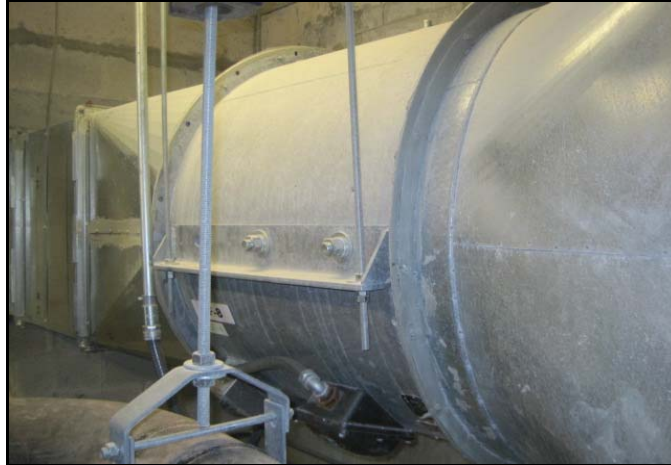
Location: Tops of stairwells, mechanical room

Evaluation: (1) 15 HP fan at mechanical room adjacent to cooling tower, and (1) 10 HP fan on the top of each stairwell. All appear to be original to the building. Should be inspected and serviced regularly to ensure proper function.

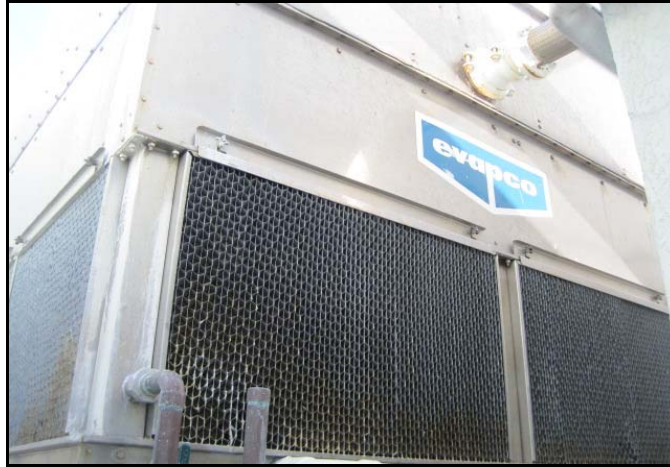
Comp #: 2533 Cooling Tower - Replace

Evaluation: Evapco tower, model USS-29-421. 467 nominal tons. Reported to be functioning properly with no unusual problems or signs of age. This component factors periodic total replacement of cooling tower. The system should be inspected and serviced regularly throughout its life cycle to ensure optimal performance and attain a full useful life. As remaining useful life approaches zero, consult with HVAC vendors to determine options for replacement. In many cases, more efficient systems are available that may have a higher initial cost, but are advantageous over the long term due to lower energy usage. In many cases the "payback" period for efficient HVAC systems is a fraction of the actual useful life of the system. Continue to proactively maintain and ensure proper water chemistry to extend life as much as possible.

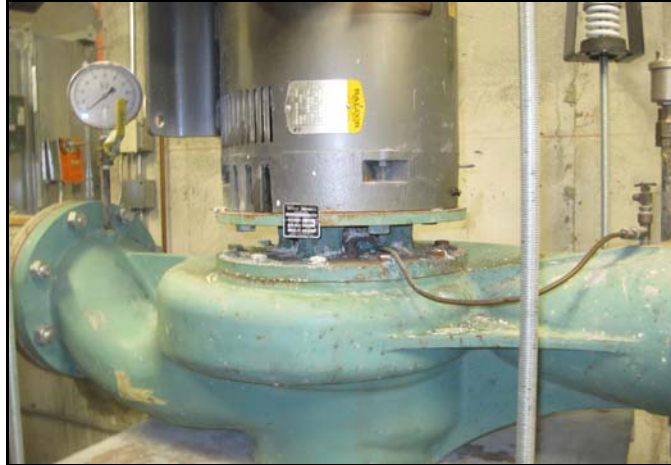
Comp #: 2535 Cooling Tower Pumps - Replace

Evaluation: (2) condenser water pumps are 40 HP and 25 HP. Both appear to be original. Should be inspected and serviced regularly to ensure a full useful life. No reports of any unusual problems or conditions at this time.

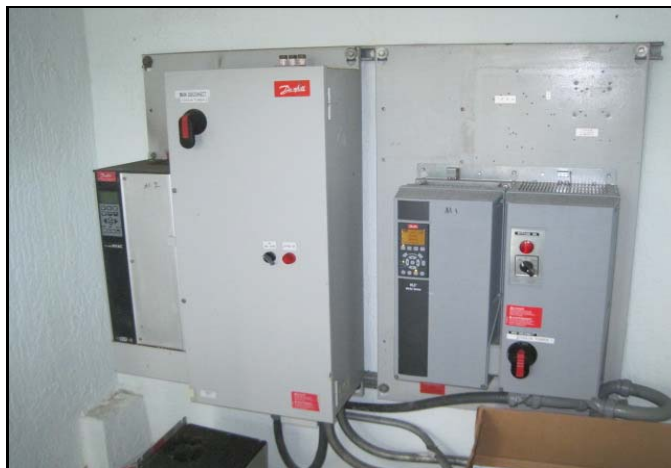
Comp #: 2537 Variable Frequency Drives - Replace

Evaluation: One is original to 2006, and the other was replaced in 2008 according to building engineer. Variable frequency drives (AKA variable speed drives) are used to control output of mechanical equipment when full power is not required at all times. Should be inspected and repaired as needed by servicing vendor to ensure proper function and optimal performance. Unless otherwise noted, assumed to be functional and in good condition. Plan to replace at the approximate interval shown below. The "payback" period for these systems, measured in energy savings, is often a fraction of the design life of the unit itself.

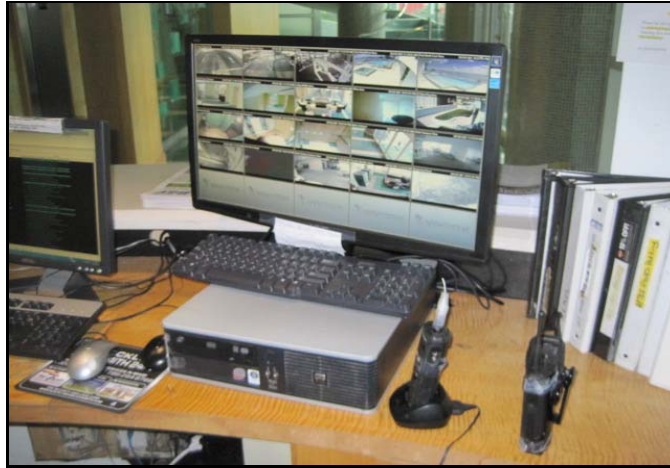
Evaluation: There are actually 20 cameras on the property, according to manager, but one is owned by a third-party. Security/surveillance systems should be monitored closely to ensure proper function. Whenever possible, camera locations should be protected and isolated to prevent tampering and/or theft. Plan to replace/upgrade the system at the approximate interval shown below. Typical modernization projects may include addition and/or replacement of camera fixtures, recording equipment, monitors, software, etc. In many cases, replacement or modernization is warranted due to advancement in technology, not functional failure of the existing system. Keep track of any partial replacements and include cost history during future Reserve Study updates.

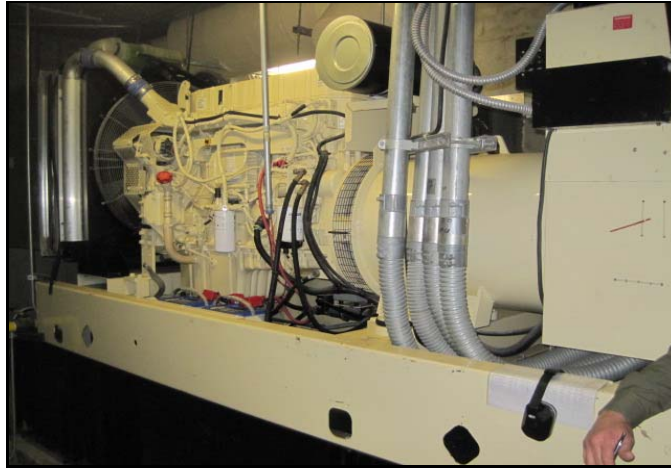
Comp #: 2549 **Generator - Replace**

Evaluation: Generator only provides emergency power to emergency systems, hallways, etc., not to unit interiors. Vendors typically report that with ongoing maintenance (e.g. fluids, batteries, tune ups), useful life can be extended for many years, sometimes 50 years or more. However, funding for complete replacement is often warranted due to lack of available replacement parts rather than failure of the system as a whole. Treat periodic service and inspect as general maintenance expense within Operating budget, not Reserves. Generator is a key building element in this location due to risk of severe storms and power outages, and should be tested evaluated regularly to ensure proper function.

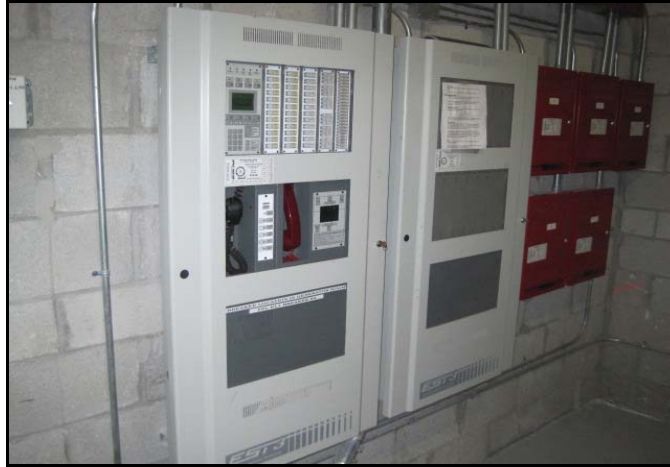
Evaluation: Edwards EST3 control panel. Device counts as listed on inspection records: (86) pull stations, (202) photoelectric smoke detectors, (8) duct smoke detectors, (9) heat detectors, (27) waterflow switches and (42) speaker/strobes. Unless otherwise noted, fire alarm equipment is assumed to have been designed and installed properly and adheres to all relevant building codes. Regular testing and inspections should be conducted as an Operating expense. In many cases, manufacturers discontinue support of equipment after a certain number of years, which may limit availability of replacement parts as the system ages. Research and experience suggests planning for replacement/modernization at roughly the time frame below. Begin formulation of specifications and obtain estimates in advance of need - replace proactively to ensure safety.

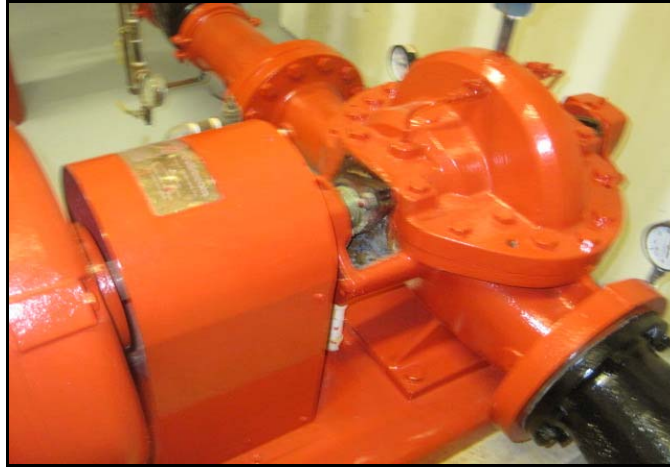
Evaluation: 150 HP Marathon Electric motor shows 2005 manufacture date. Jockey pump was recently replaced according to building engineer, but no significant issues with the main pump. Pump was not tested during site inspection, and is assumed to be functional unless otherwise noted. Fire sprinkler/suppression pump and control panel should have a long useful life expectancy under normal circumstances. Should be inspected, tested and repaired as needed on a regular basis by qualified vendor to ensure optimal performance. Over time, replacement parts may not be available and the association may need to replace the entire assembly prior to actual functional failure as a safety precaution. This component should be re-evaluated during future Reserve Study updates to incorporate any new information available at that time.

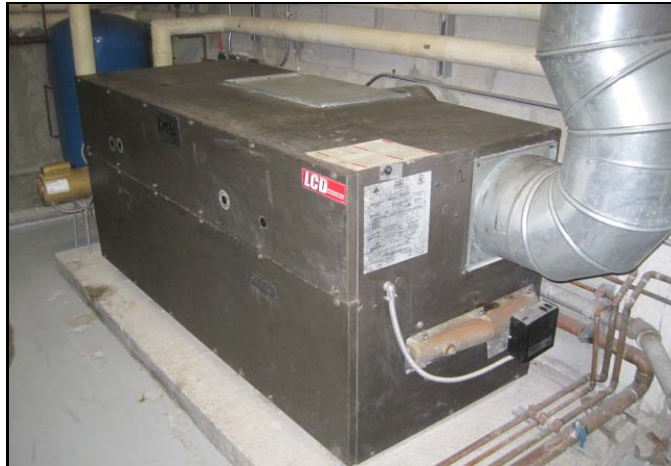
Comp #: 2571 Boilers - Replace

Evaluation: RBI boilers, model LWO1480, serial numbers 050538591 and 050538592. With routine inspection and maintenance, the boiler should have an approximate useful life as shown below before replacement with future technology and efficiencies will be warranted. Life expectancy can vary based on level of use and location on the property. When considering replacements, the association should strongly consider replacing with high-efficiency models. Although initial cost may be higher than conventional alternatives, the payback period in energy savings is often a fraction of the overall life span of the boiler itself.

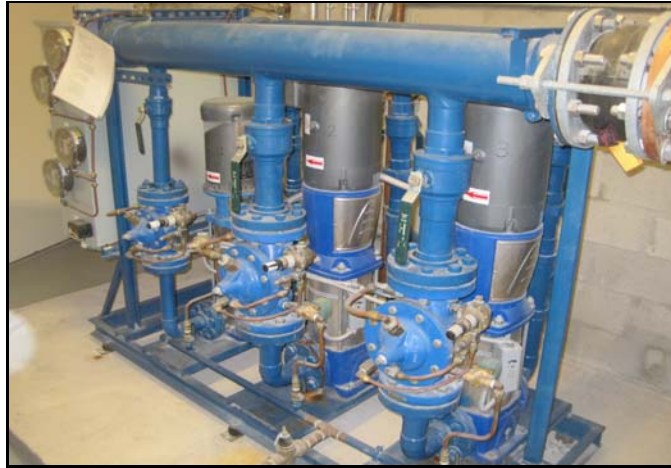
Comp #: 2575 Dom. Water Pumps/Controls - Replace

Evaluation: Sentry Pak system, model B408T143-3V. (2) 20-HP pumps and (1) 7.5 HP. All appear to be original to the building. No reported problems. Water pumps and control system should be inspected regularly and repaired as-needed by serving vendor or maintenance staff to ensure proper function and optimal performance. Minor repairs such as pump motor replacements, electronic system parts, etc. should be considered an Operating expense. Plan to replace the entire system at the approximate interval shown below based on our experience and research with similar systems. Total life span can vary based on level of use, preventive maintenance, quality of materials and installation, etc.

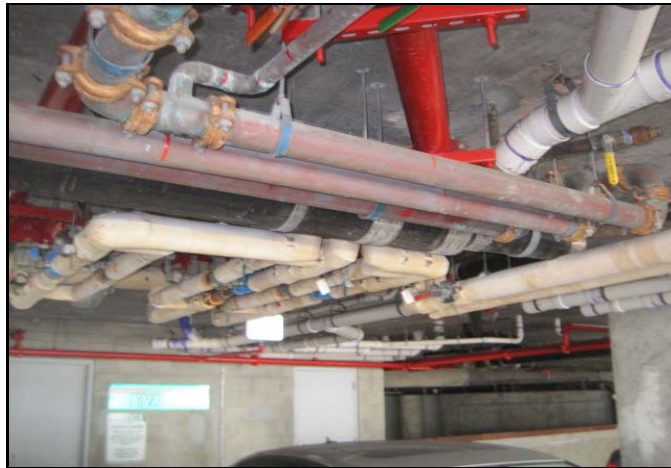
Comp #: 2579 Plumbing System - Repair

Evaluation: Analysis of plumbing system(s) beyond visual inspection of visible piping is not within the scope of a Reserve Study. Some types of piping used historically are known to be life limited. Manufacturing defects may become apparent from time to time and certain site conditions can contribute to premature deterioration of system components. Typically, if installed per architectural specifications and local building codes, there is no predictable time frame for large scale repair/replacement expenses within the scope of our report. If leaks, poor flow, sediments, defective material and/or installation become evident, have qualified plumber and/or engineer evaluate in more detail and develop scope of any repair/replacement needed; funding for even one time projects can be incorporated within Reserve Study updates if warranted. Treat minor local repairs as ongoing maintenance expense. If patterns of significant repair costs emerge, funding may be incorporated into future Reserve Study updates to supplement the Operating budget. No basis for Reserve funding at this time.

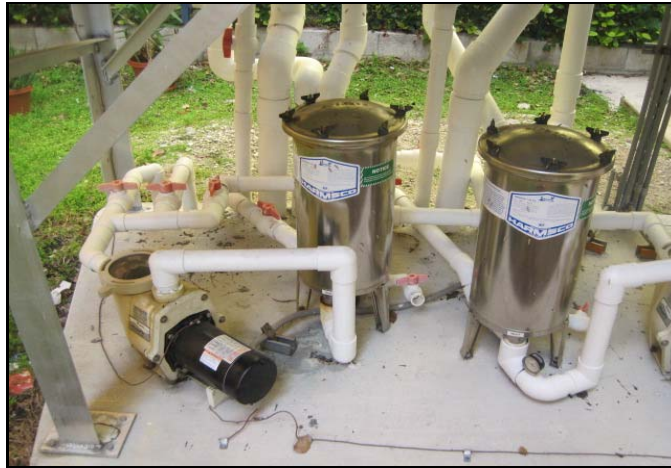
Comp #: 2593 Fountain Equipment - Replace

Evaluation: Front fountains use (4) 2 HP pumps, (2) 1 HP pumps, and (2) Harmsco filters. Building engineer reports that there is also one pump and filter for the 8th floor sundeck fountain. No need or expectation to replace all at one time. An allowance for smaller, ongoing repair/replacement projects is recommended here.

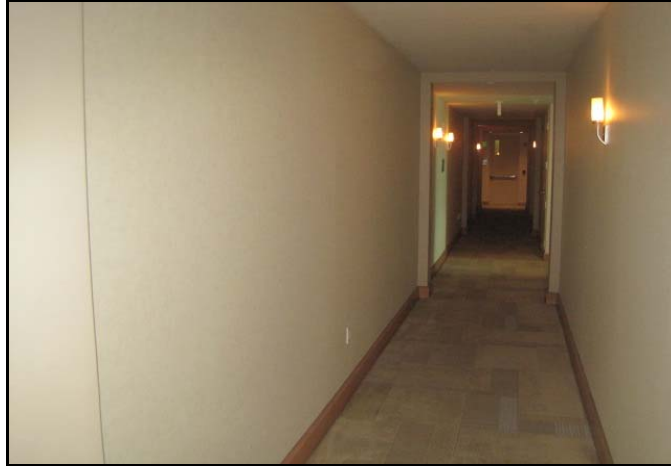
Comp #: 2703 Wallcoverings - Replace

Evaluation: Two types of wallcoverings noted. Wallcoverings should be replaced eventually to update appearance of common/amenity areas. Best practice is to coordinate at same time as other interior projects whenever possible to minimize downtime and maintain consistent quality standard. Timing and interval is subjective. Estimates shown here are based on our experience with similar properties and general aesthetic qualities. Schedule can be updated/adjusted at the discretion of the association for planning purposes.

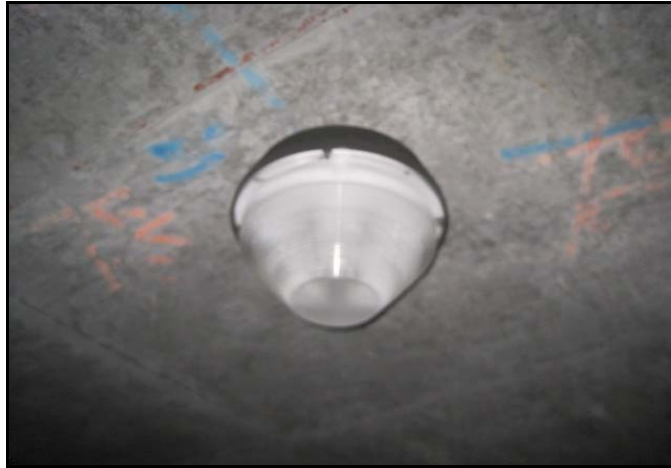
Comp #: 2705 Garage Ceiling Lights - Replace

Evaluation: Large fixtures, seen during daylight hours. As routine maintenance, inspect, repair and change bulbs as needed. Estimates shown here are based on our experience with similar properties and general aesthetic qualities. Schedule can be updated/adjusted at the discretion of the association for planning purposes. Funding recommendations are based on replacement with comparable quality fixtures.

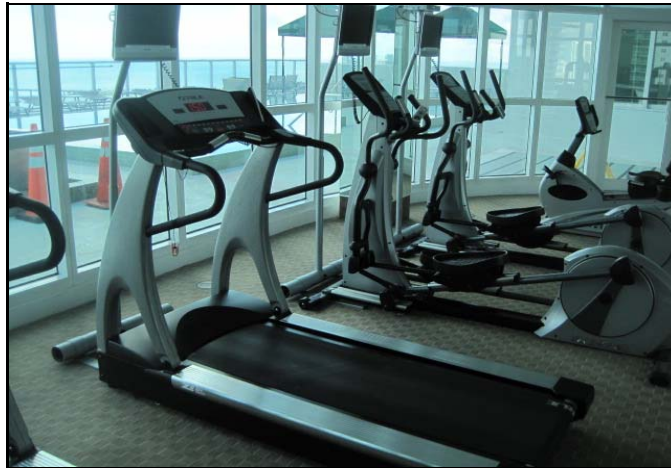
Comp #: 2727 Fitness Equipment - Replace

Evaluation: High-end commercial pieces in good condition. Cardio machines have individual TV screens.
